January 13, 2023

Re: Report of Geotechnical Engineering Subsurface Characterization
Evaluation of Mine Spoil Site for Residential and Commercial Development
Chestnut Ridge Site
Leburn (Knott County) Kentucky
Vector Project Number 22.05.0160 SHE

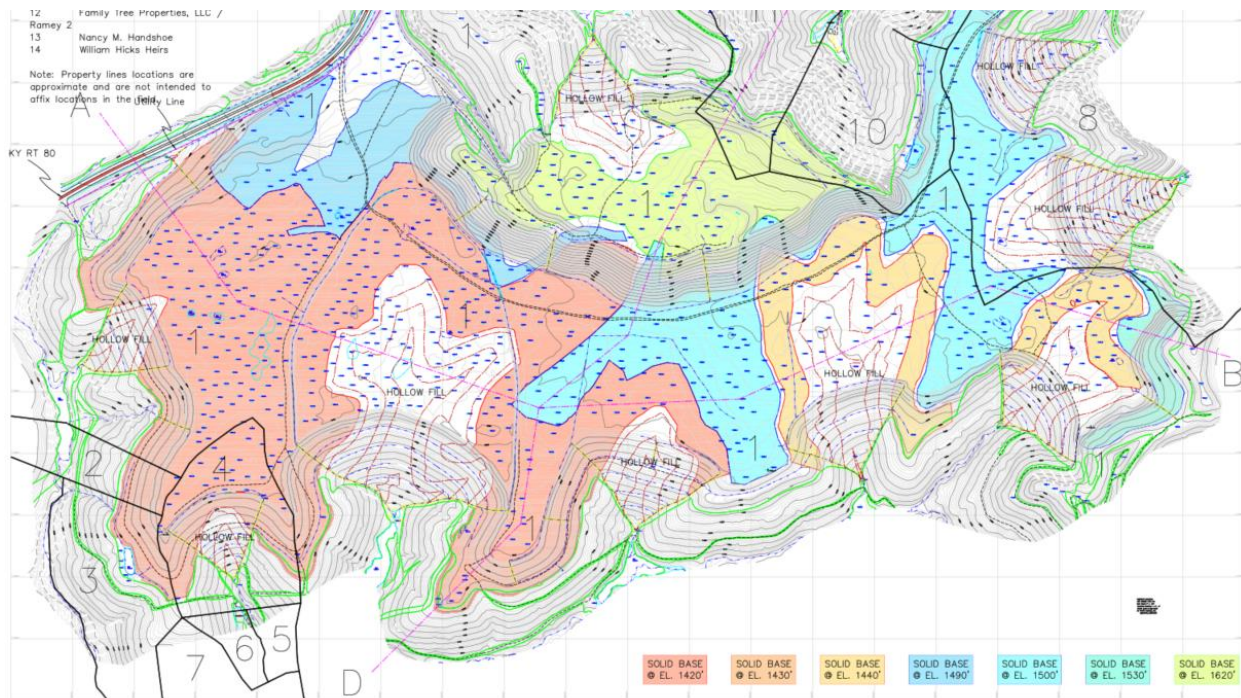
Figure 8: Drawing of the bottom of the mine excavation (solid base).

The depth of the mine spoil in the areas range considerably. The top of ground elevations are about 1515 feet to 1520 feet on the western section of the site (orange shading on Figure 8) where the bench elevation is reported to be 1420 feet, making the mine spoil depths about 100 feet thick.

The area on the northern section of the site near the development entrance road indicated by the blue shading in Figure 8 has top of ground elevations of about 1490 to about 1530 feet msl making the depth of mine spoil to the bench elevation of 1490 feet about a few feet to about 40 feet.

The area near the center of the site (light blue shading in Figure 8) has top of ground elevations ranging from about 1520 to about 1530 feet msl making the depth of fill to the mine bench (1500 feet msl) about 20 to 30 feet thick.

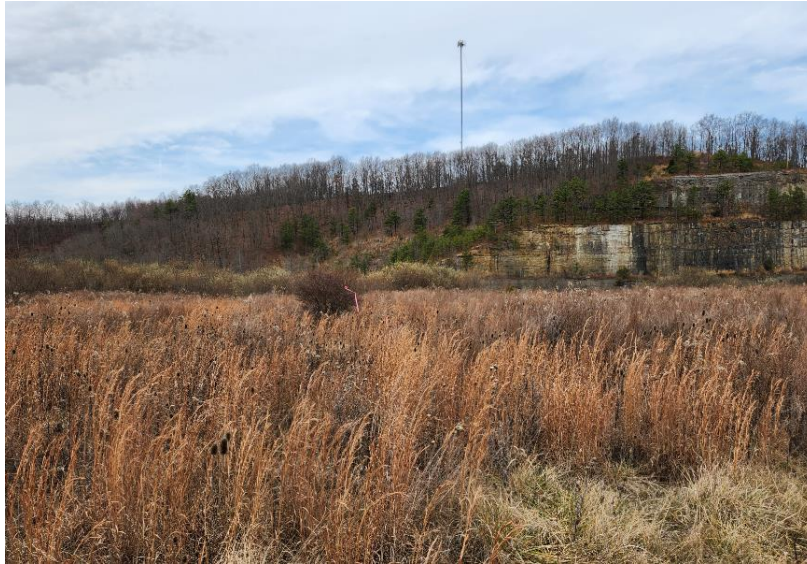
Photograph No. 1: View looking west toward boring B-1 (pink flag) and toward Highway 80. The cut is on the west side of highway 80.

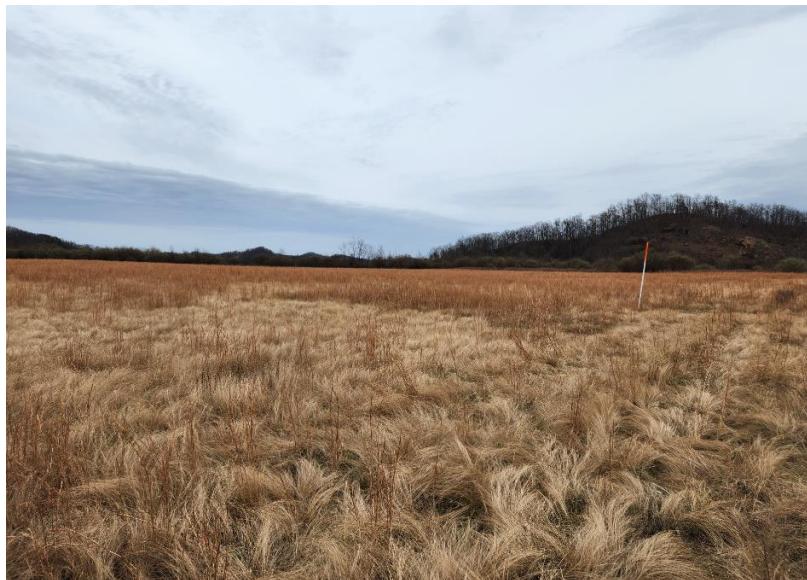
Photograph No. 2: View looking east toward Boring B-10.

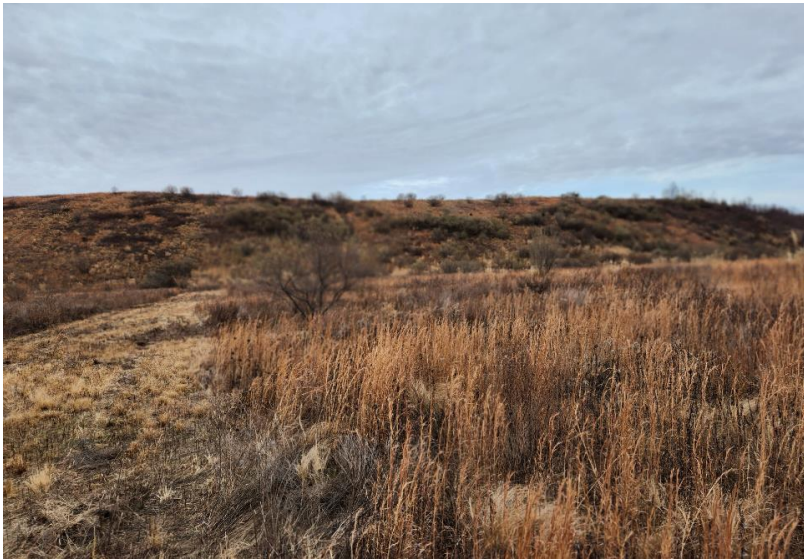
Photograph No. 3: View looking North towards the upper plateau area.

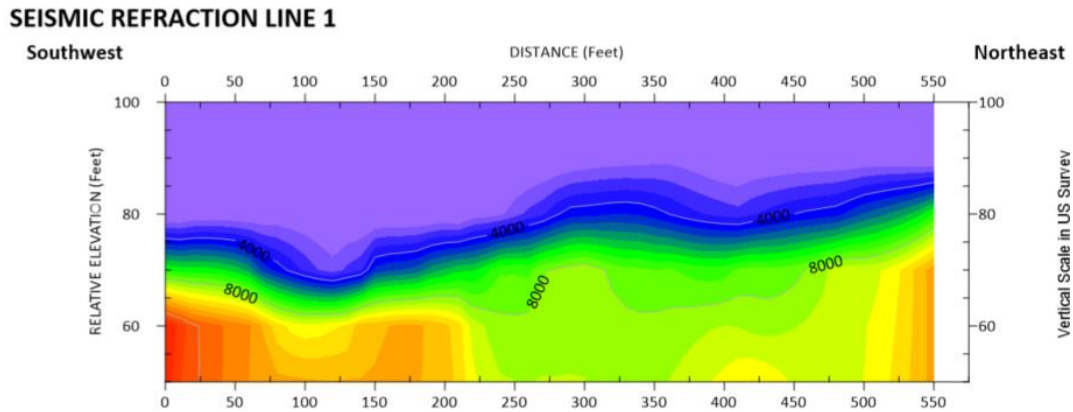
Seismic Refraction (SR) Line 1 suggests competent bedrock exists at shallow depths (about 30 feet or more) beneath the line location. The dark blue to green transition is the area where we interpret the mine bench. Boring B-2 was drilled within

200 feet (to the southeast) of the northeastern end of SR Line 1. Boring B-2 encountered refusal at a depth of 33.4 feet from top of ground. This corresponds well to the seismic refraction data. The data collected along SR Line 1 do not show a clear bench feature (sharp increase in the interpreted depth to rock) at the documented boundary of a transition from solid base material at elevation 1,490 feet to solid base material at an elevation of 1,420 feet. This may represent a concentration of boulders that were back stacked against the old highwall from one bench to the other.

Figure 11: Results of Seismic Refraction Survey along line 1.
The green area is representative of suspected bedrock benching.

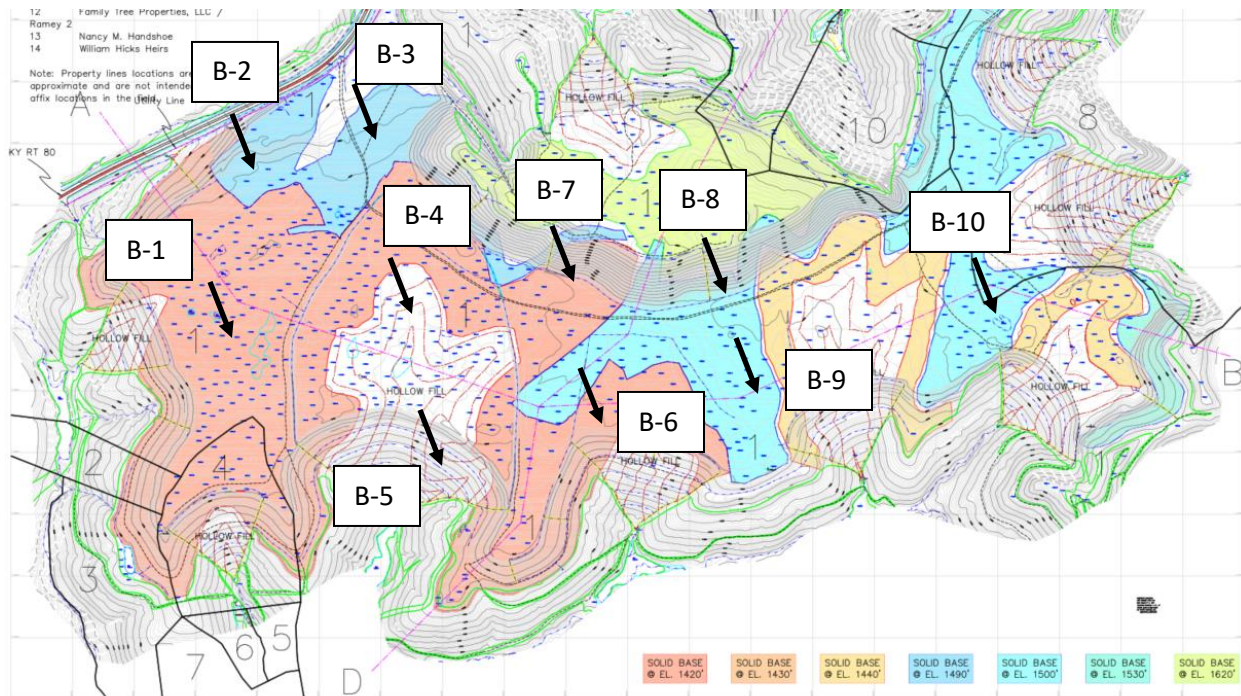
The borings were located at specific bench locations to verify the depths indicated on the “Solid Base” Map. The borings generally encountered refusal within a reasonable depth that agreed with the mapping. Table 1 lists the interpreted depth to the bedrock bench based on our review of the soil and rock specimens. On the boring logs, some of the coring conducted through refusal material was judged to be large boulders within the fill and not actual bedrock bench depths.

Figure 9: Approximate Borehole locations compared to bench map.

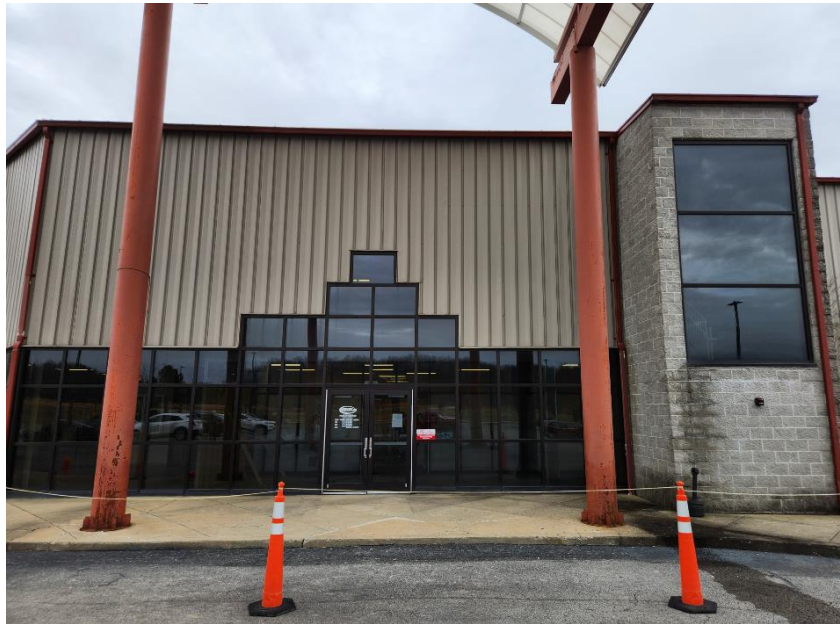
Photograph No. 4: Front View of the Sportsplex

The Knott County Sportscenter is located at the southeastern portion of the site. The building is a steel framed, metal sided, high bay structure with a glass and CMU block façade. The building has a lower masonry wall around the building. The structural cracking appears to be limited to the front two story section of the building. There is extensive structural damage to the front stairwell and upper floor of the front section of the building. The two-story office and classroom portion of the building has been closed off to the public due to the damage. The CMU block wall around the sides and back of the building did not show obvious settlement cracking. The following photographs illustrate the damage.

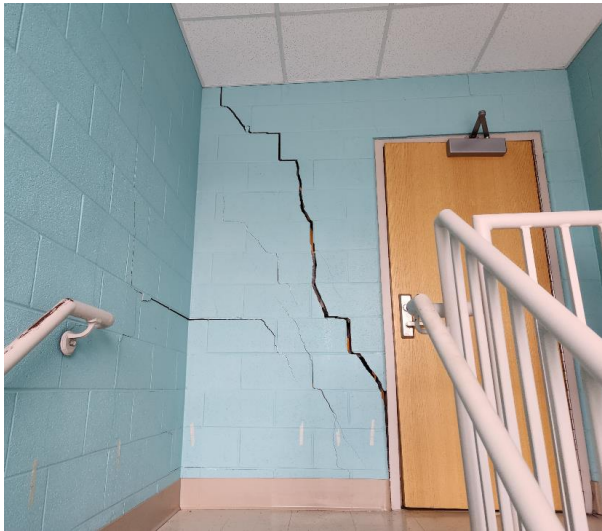
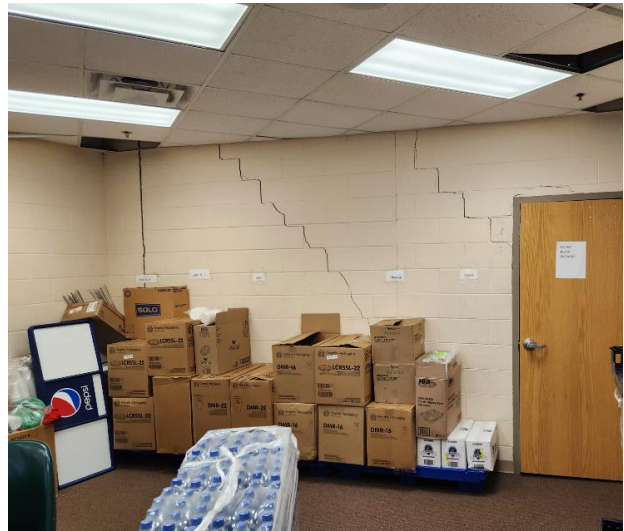
Photographs No. 5 and 6: Cracks in upper floor of stairwell and storage room.

are assuming conventional spread footings. Based on the mapping reviewed for this site, it appears that the building is partially underlain by a hollow fill and partially on the 1420 feet msl bench. If the fill was completed shortly before construction (within 5 years or so) then the primary consolidation of the fill due to self-weight was still occurring. This may explain the settlement. Additionally, there was evidence of water overflowing the gutters (water stains, wet blocks, and algae growth on the blocks) which may have contributed to hydrocompression.

The selection of the foundation type for the proposed development would typically consist of conventional shallow spread footings. However, considering the performance of the existing Sportsplex building, we recommend a modified spread footing consisting

of an inverted “T” type footing that is rigid to allow for uniform movements and reduce the risk of cracking of masonry or brick walls. The foundation can be designed using a bearing capacity for the mine spoil of up to 3000 psf. The structural engineer should consider top and bottom reinforcement in all foundations as well as reinforcement in the stem wall.

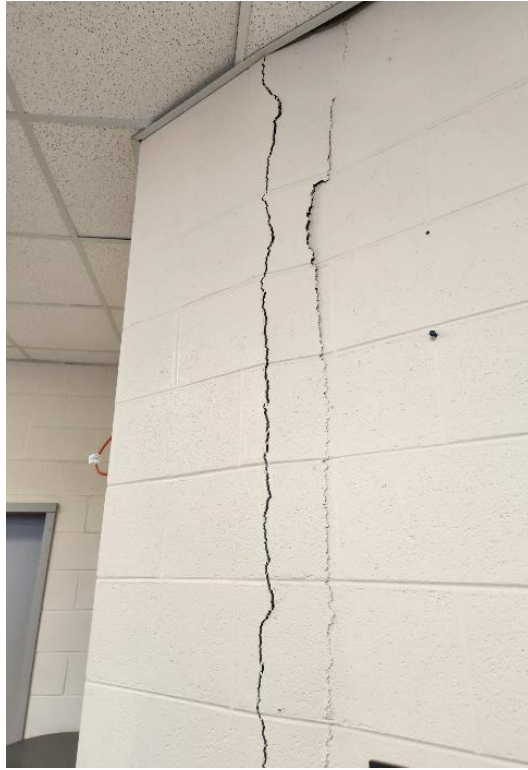
Photograph 7: Upper-level cracking in front room.
