January 13, 2023

Re: Report of Geotechnical Engineering Subsurface Characterization
Evaluation of Mine Spoil Site for Residential and Commercial Development
Chestnut Ridge Site
Leburn (Knott County) Kentucky
Vector Project Number 22.05.0160 SHE

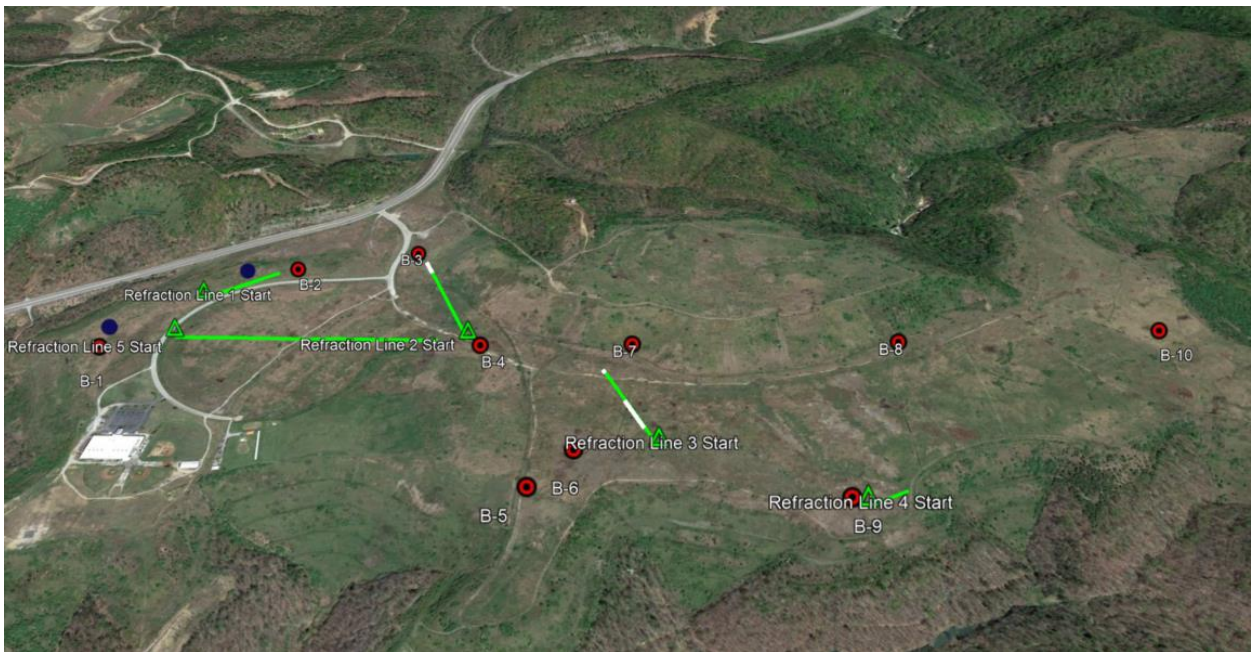
Figure 9: Seismic refraction lines and boring locations

Geophysical (seismic) data were collected along 5 survey lines to gather information about the density of subsurface materials. Specifically, a seismic refraction survey was conducted to evaluate the subsurface compressional-wave velocity variation along each survey line. Compressional-wave velocity is a function of the density, bulk modulus, and shear modulus of the material. The data were used in combination with boring data to estimate the characteristics of the geologic materials. The seismic refraction survey line locations are shown in Figure 9 and 10. Figure 10 illustrates the reported bench locations as well as the boring locations.
