Subject:       Compilation of Geotechnical Submittals  
                  **Skyview Estates**  
                  Hazard, Kentucky  
                  Project Number: 24020013SHE

**Geotechnical Engineering  
Exploration**

**Sky View Estates  
Perry County, Kentucky**

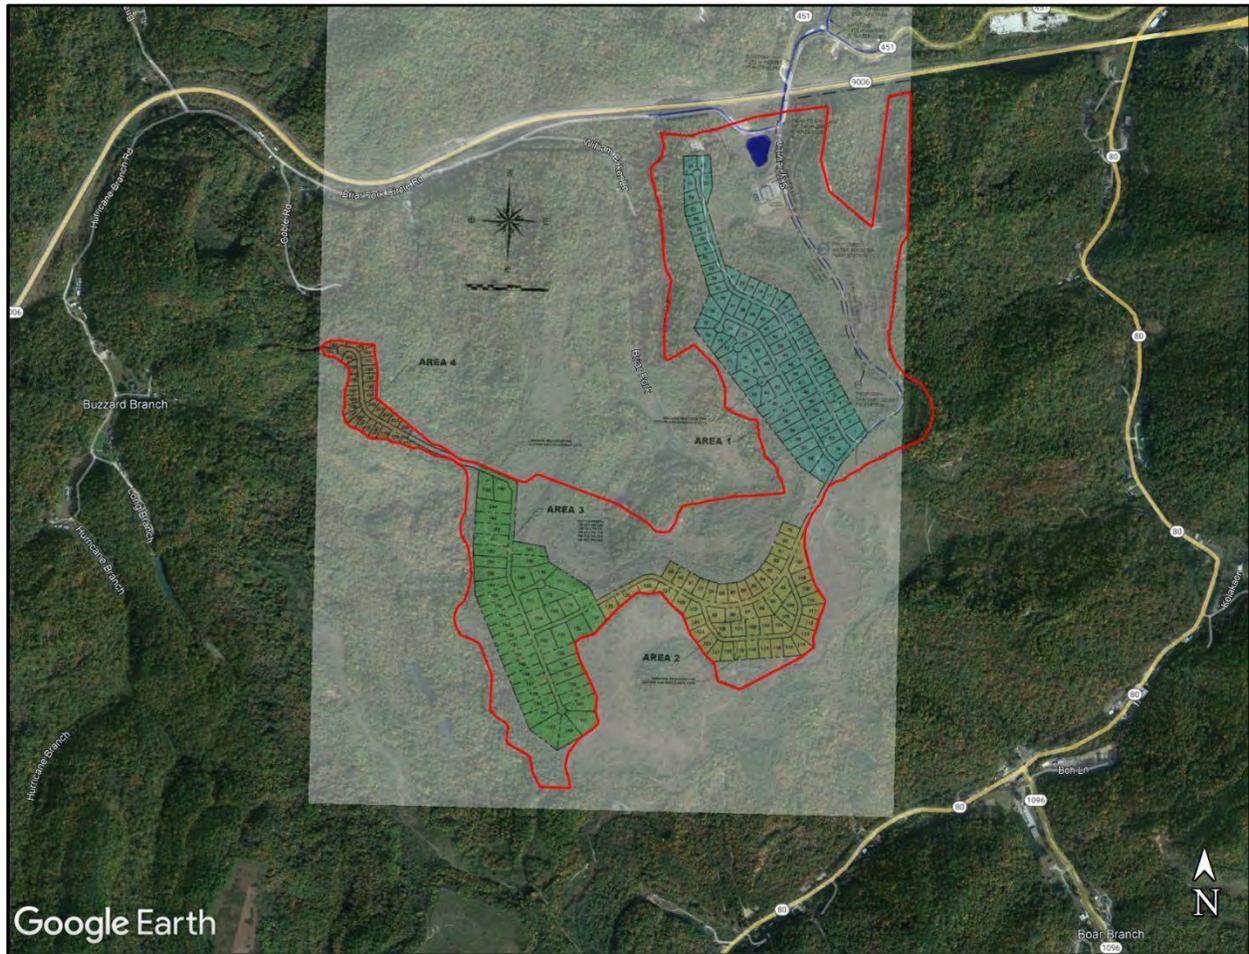
**Picture 2: Overlay of Conceptual Site Plan**

An overlay of the preliminary conceptual plan completed by R.M. Johnson Engineering, Inc. is shown in Picture 2 below.

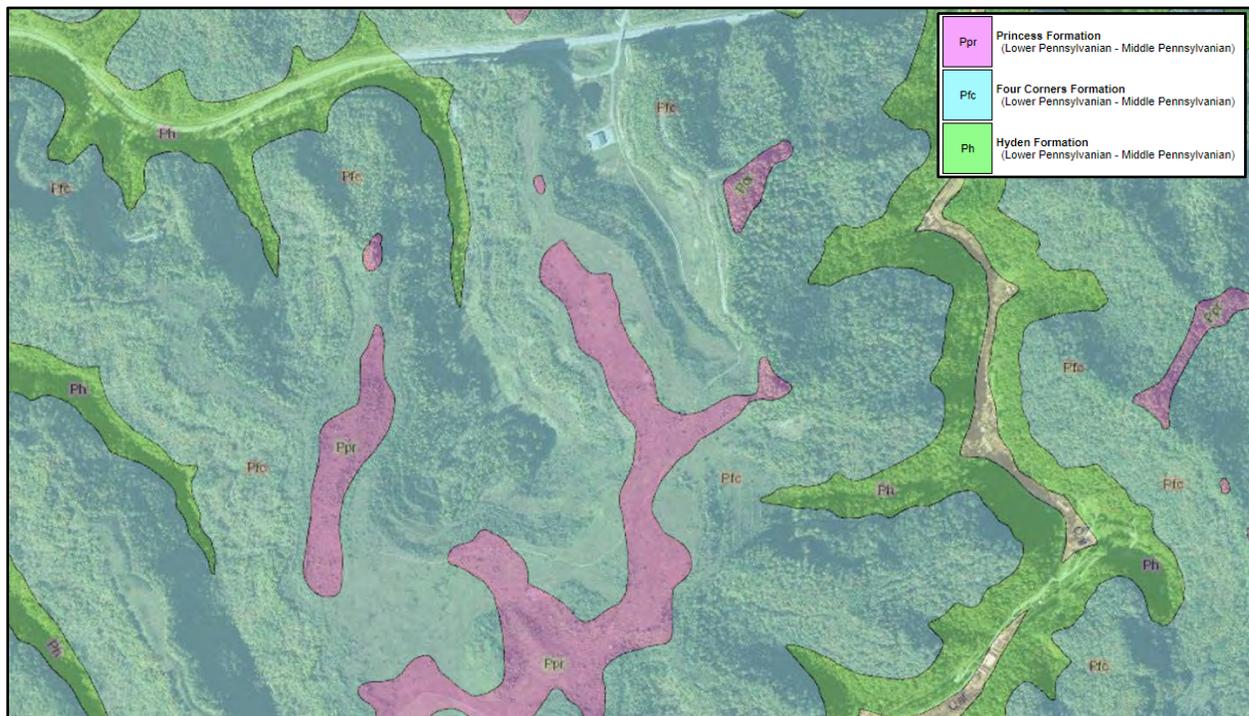
**Picture 3: Bedrock Geology**

The Four Corners Formation is composed of sandstone, shale, siltstone, and coal. The sandstone is generally light- to medium-gray, medium-grained, poorly sorted, and crossbedded. The shale and siltstone are generally olive-gray to medium-gray, poorly exposed, and forms a subdued bench at about the level of Francis coal bed. The Hazard No. 7 coal bed at the base of the

The Princess Formation also consists of sandstone, shale, siltstone, and coal. The sandstone is generally light- to medium-gray, medium- to coarse-grained, poorly sorted, and crossbedded. The sandstone above the Hindman coal bed characteristically forms bold cliffs and pinnacles. The shale and siltstone are generally olive-gray to dark-gray, micaceous and contain fossil plant fragments. A shale roof is most common in the southern part of quadrangle and a sandstone roof in the northern part.

The Hyden Formation consists of sandstone, siltstone, shale, underclay, and coal. The upper part of the unit is predominantly sandstone which is light-gray, fine- to medium-grained, thick- to very thick bedded, and generally crossbedded. The Hamlin coal zone includes 1 to 5 coal beds, each generally 4 to 10 in. thick. The coal beds appear to grade laterally into carbonaceous shale. The Lower part of the unit is mainly light- to dark-gray shale and siltstone except where replaced locally by channel sandstone. The Fire Clay rider coal bed is 8 to 40 ft. above the Fire Clay bed.

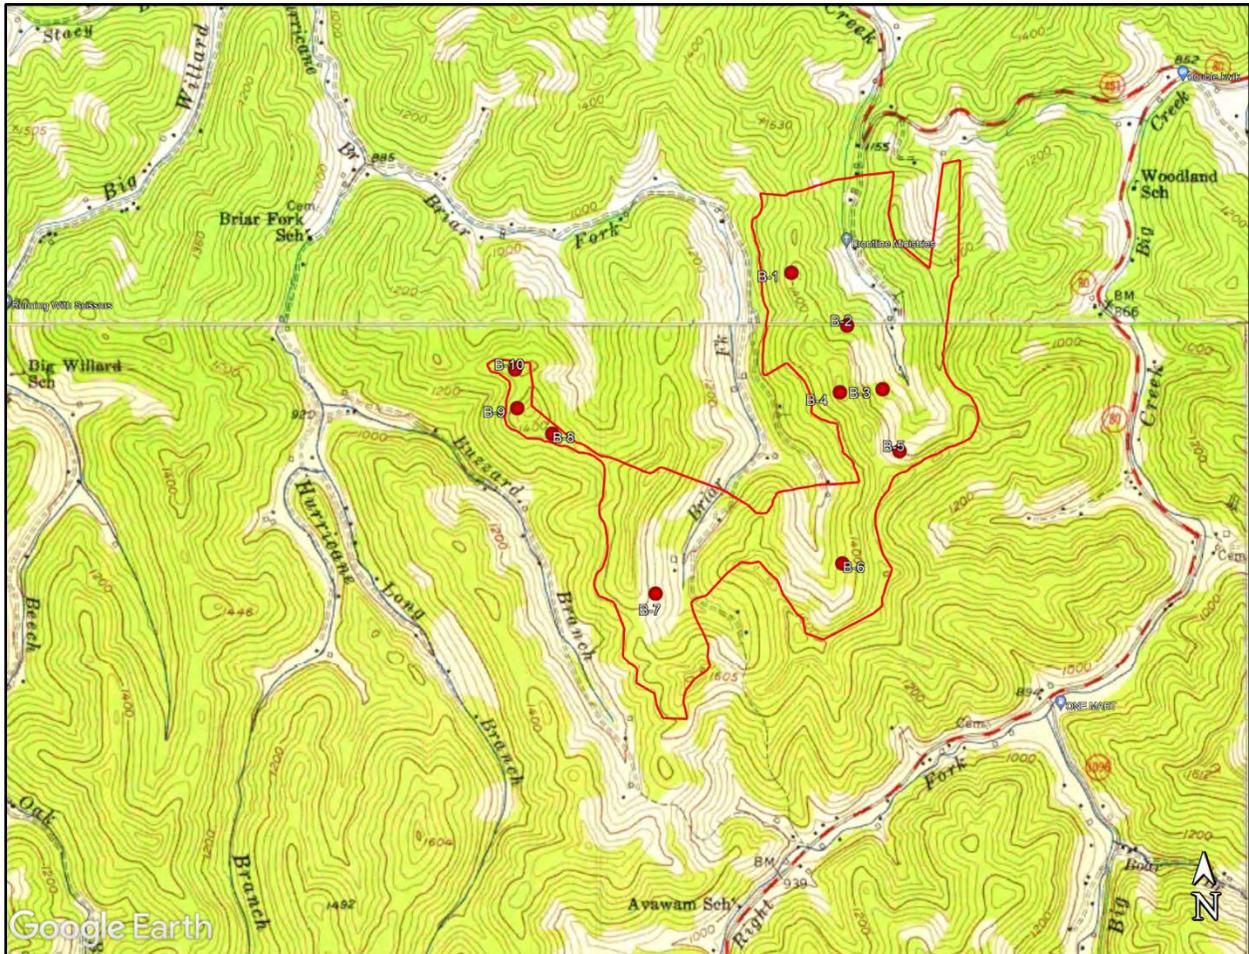
**Picture 4: Site Topography in 1954**

Based on a review of the Kentucky Mine Mapping System (KMMS), there has been extensive mining, consisting of both underground and surface, in the area for coal since the early 1960's. As the result, numerous abandoned audits, strip benches, and other excavated depression-like features are found throughout the area. The site has been mined in the recent past and the original contours have been significantly altered by both mining and highway construction. The image below shows the contours present on the site in 1954. The image was taken from the Krypton 7.5 min. Topographic Quadrangle Map and the Hyden East 7.5 min. Topographic Quadrangle Map

both published in 1954 by the United States Geological Survey. When comparing the contours present in 1954 with the current topographic mapping, there are significant differences caused by the mountaintop removal and contour mining that has been completed.

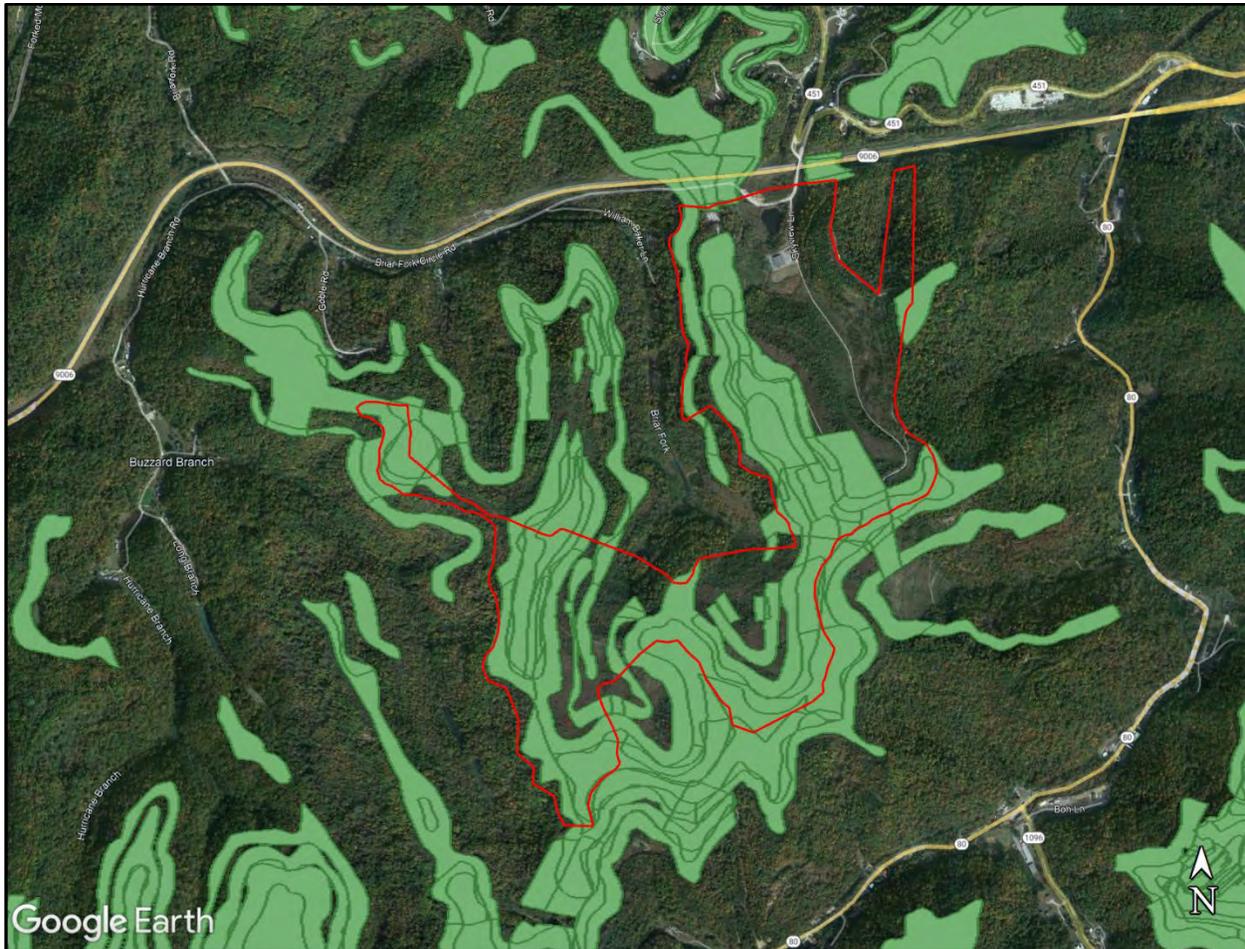
**Picture 5: Formerly Mined Out Areas**

The KMMS indicates mined out areas on site which are shown below in green. As previously mentioned, the red outline is the approximate site boundary. A majority of the mining was completed in the 1960's and 1970's by various coal companies. Based on historical aerial imagery, mine maps obtained from the Commonwealth of Kentucky, and observations from the field exploration, the site has been reclaimed by the placement of mine spoils. A reclamation plan submitted by Leslie Resources, Inc. indicates that reclamation activities were completed by the end of 2000.

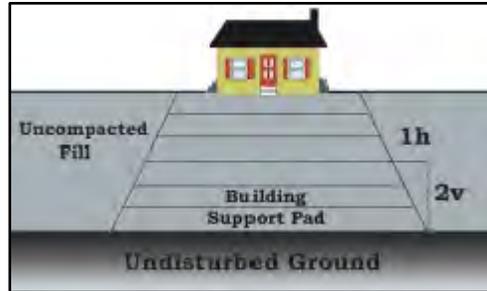
**Figure 2: Undercutting and Replacement**

Undercutting and replacing the spoil as a controlled engineered fill material would create a more homogeneous bearing surface for the building. This pad would extend beyond the limits of the building and act as a mat below the structure to limit the effects of differential settlement. See the figure below:

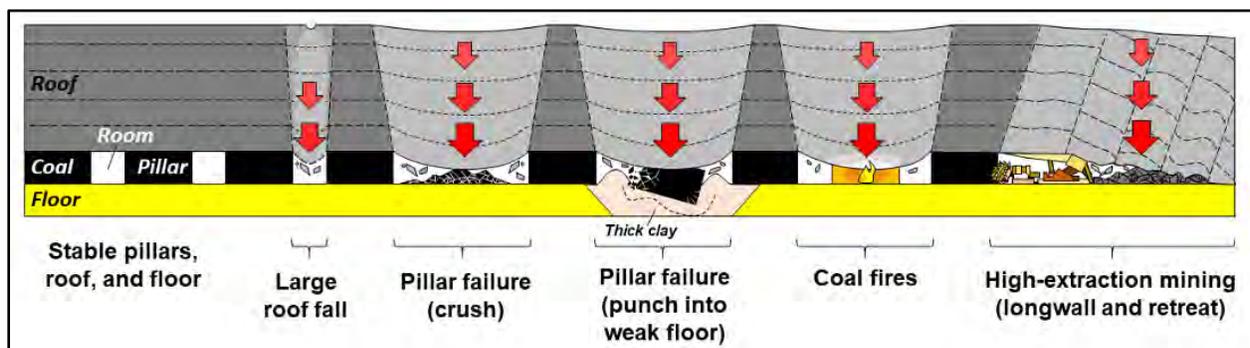
**Figure 3: Underground Mine Subsidence Causes**

As previously mentioned, underground mining activity consisting of room and pillar mining has been completed at various locations around the site. The coal seam is accessed by deep vertical shafts with elevators from the surface down to the coal. In room and pillar mining, the coal seams are mined by creating a network of rooms into the seam. As the coal is removed creating rooms, pillars composed of coal are left behind to support the roof of the mine. Each room alternates with a pillar of greater width than the excavated room for support. As mining continues, roof bolts are placed in the ceiling to prevent ceiling collapse. The pillars may be left in place or under special circumstances they may sometimes be removed or pulled toward the end of mining in a process to retrieve the remaining coal. This is called retreat mining and can lead to roof falls, so the pillars are removed in the opposite direction from which the mine advanced. Several causes of mine subsidence are shown below in Figure 2.

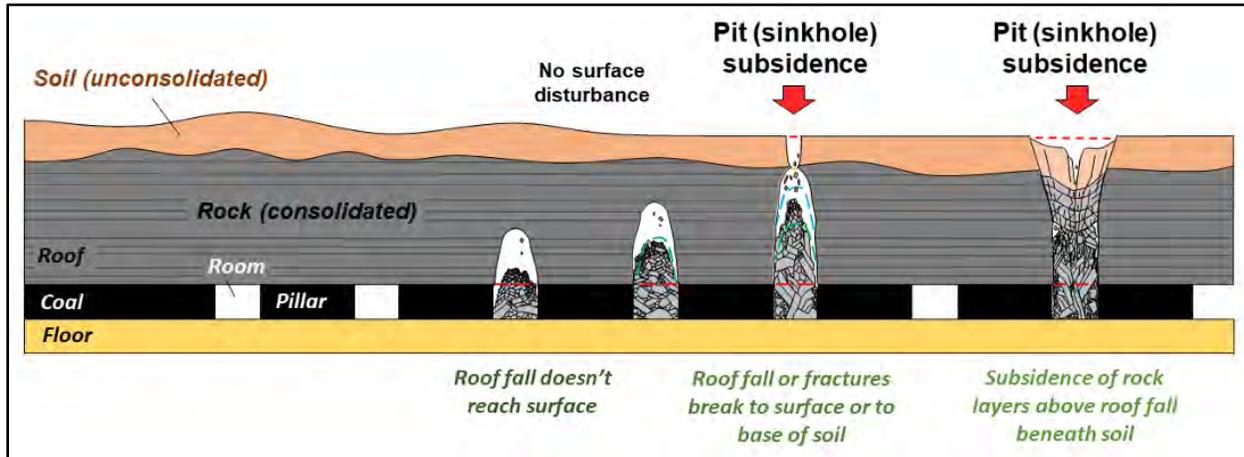
**Figure 3: Examples of Pit Subsidence**

Several different types of mine subsidence are known in the Midwestern and Eastern United States. Pit subsidence is a localized surface hole or pit that can develop above mines and is most common above collapsed rooms or entries in shallow (> 100 ft.) room and pillar mines. The majority of roof falls in underground mines only result in the collapse of the immediate roof; however, under certain conditions, these falls may continue upward and result in a sinkhole subsidence at the surface. A study in Pennsylvania found that more than half of recorded sinkhole subsidence events happened 50 or more years after mining, and a few occurred more than 100 years after mining (Gray and others, 1977; Gray and Bruhn, 1984).

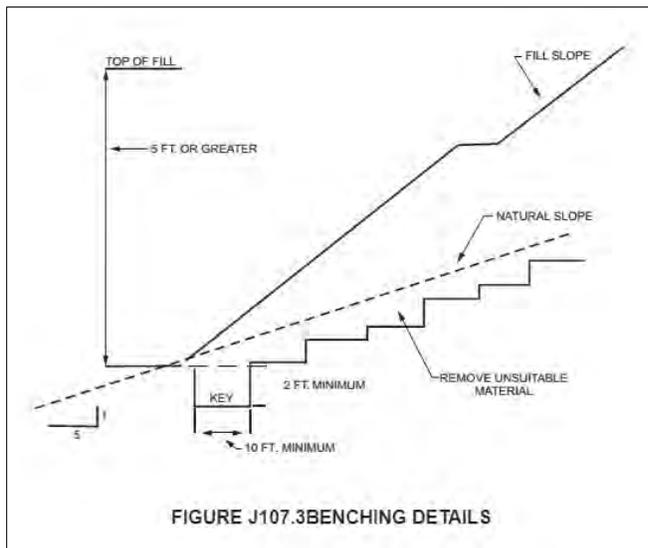
**Figure 1: Benching Details (2015 IBC)**

Permanent fill slopes should be no steeper than 2H:1V. Steeper slopes may be feasible if reinforcement is used in the design/construction. The fill material should be placed and compacted in horizontal lifts according to the project specifications and plans. The slope should be constructed by overbuilding the slope face and then cutting it back to the design grade. New fill material should be properly benched into the existing slopes as shown in the diagram below. Fill slopes should not be constructed or extended horizontally by placing fill on an existing slope face and/or compacted by track walking.

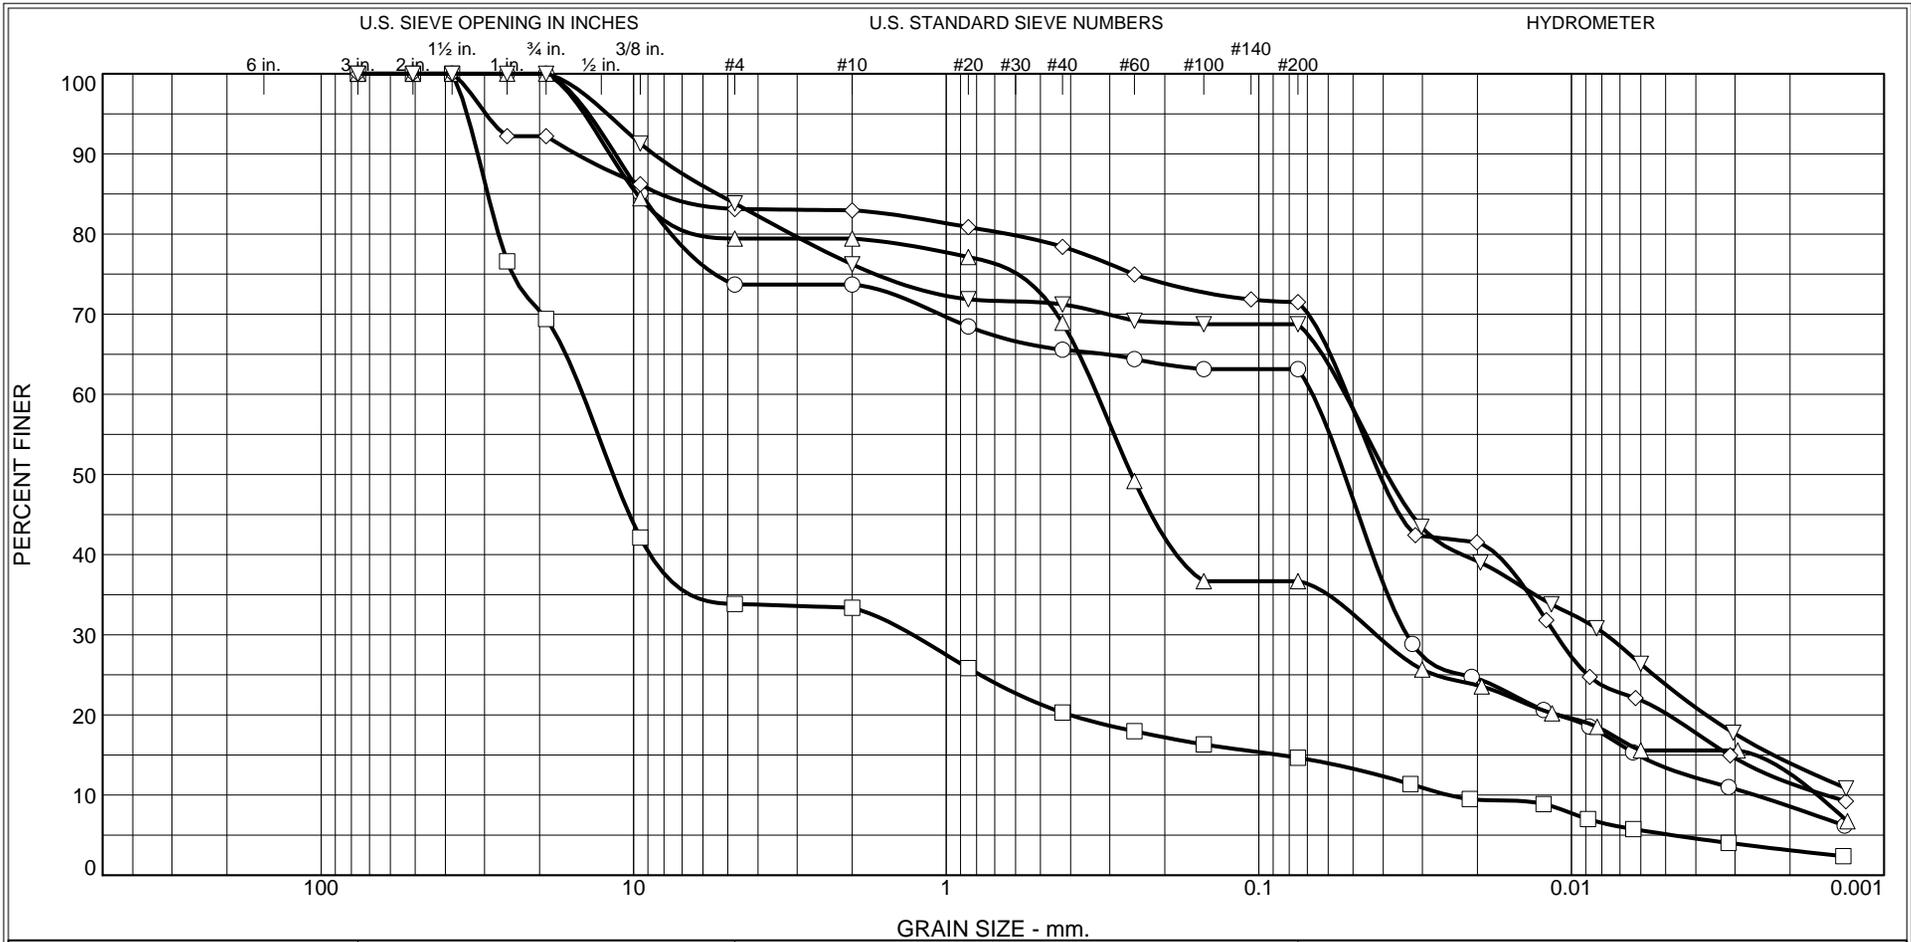
Location	Source	Sample #	Depth/Elev.	Material Description
○	B-1		24379	9.0-10.5'	Gravelly Lean Clay (CL)
□	B-4		24380	44.5-46.0'	Clayey Gravel (GC)
△	B-6		24381	59.5-61.0'	Silty Clayey Sand with Gravel (SC-SM)
◇	B-7		24382	29.5-31.0'	Sandy Silt with Gravel (ML)
▽	B-10		24383	2.0-3.5'	Gravelly Silt with Sand (ML)

Project No. 2023004	Client Commonwealth of Kentucky, DECA	Figure	L.E. Gregg Associates, Inc.
Particle Size Distribution Report			2456 Fortune Dr, Ste 155, Lexington, KY 40509
<b>Skyview Estates</b>			Phone: 859-252-7558

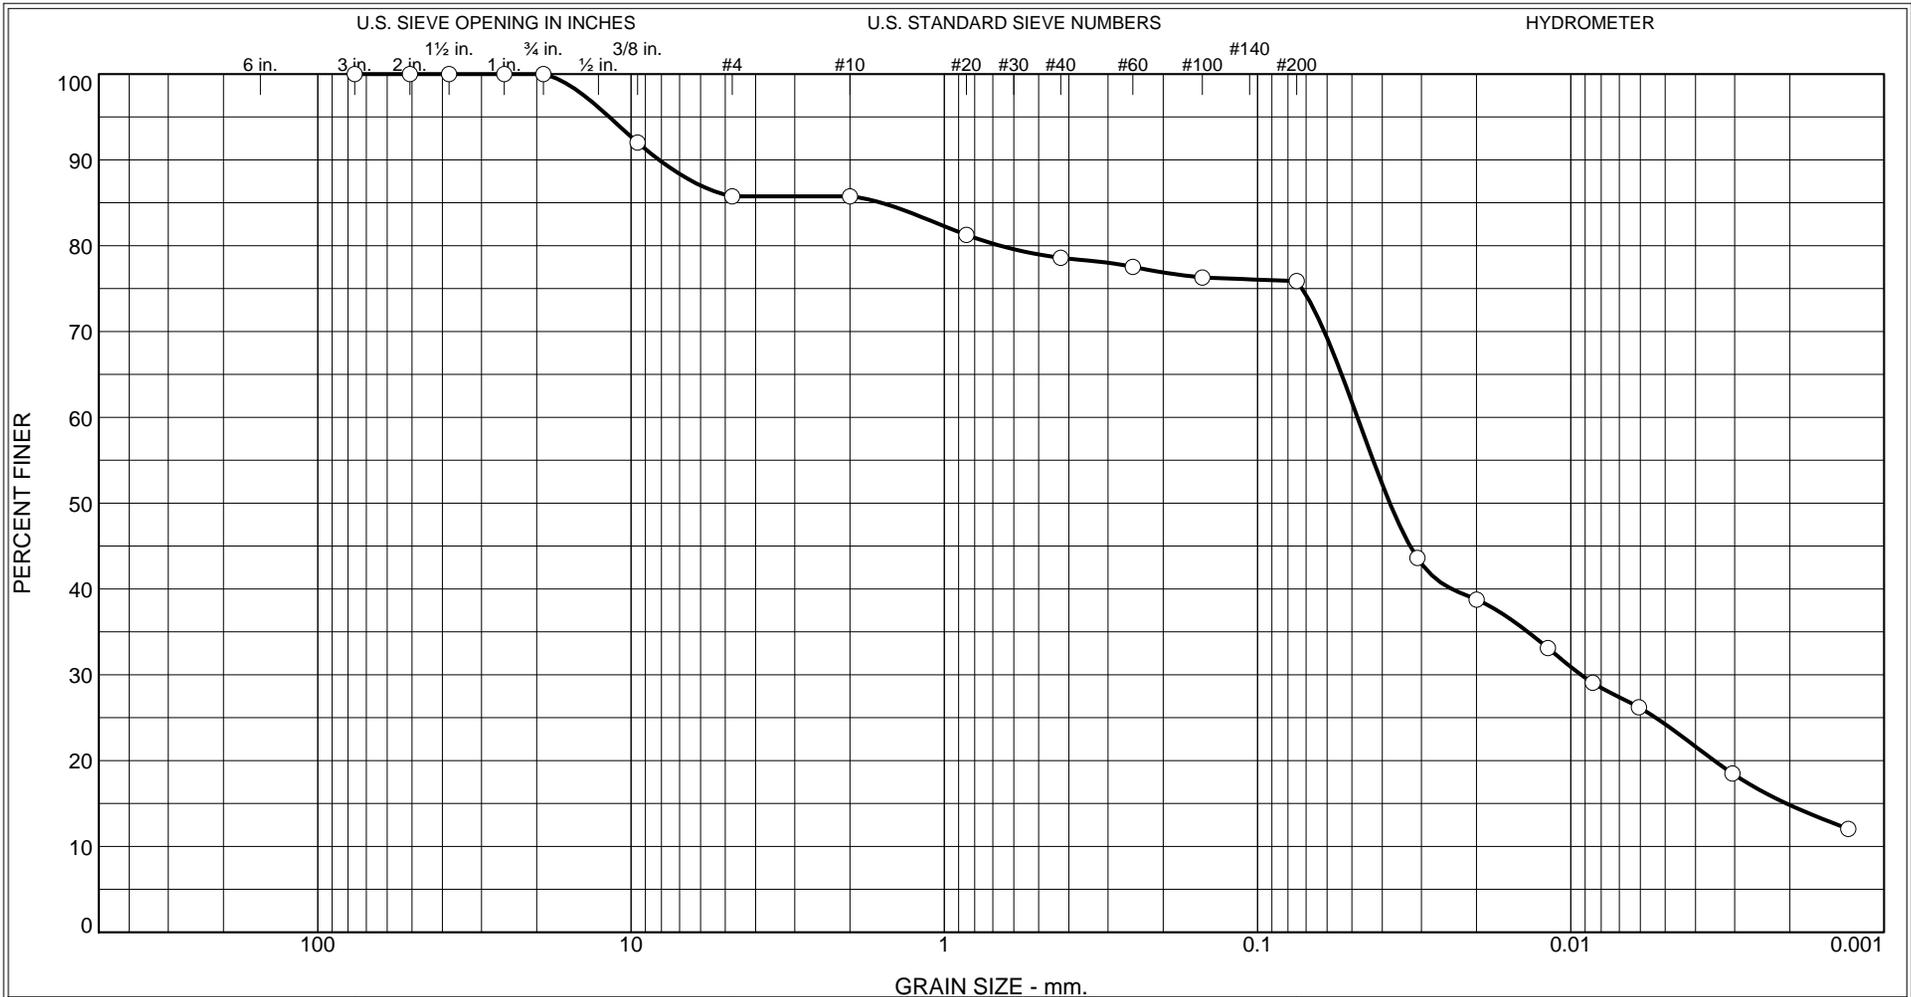
Location	Source	Sample #	Depth/Elev.	Material Description
B-7 Bulk Sample		24386		Lean Clay with Gravel (CL)

Project No. 2023004	Client Commonwealth of Kentucky, DECA	Figure	L.E. Gregg Associates, Inc.
Particle Size Distribution Report			2456 Fortune Dr, Ste 155, Lexington, KY 40509
<b>Skyview Estates</b>			Phone: 859-252-7558

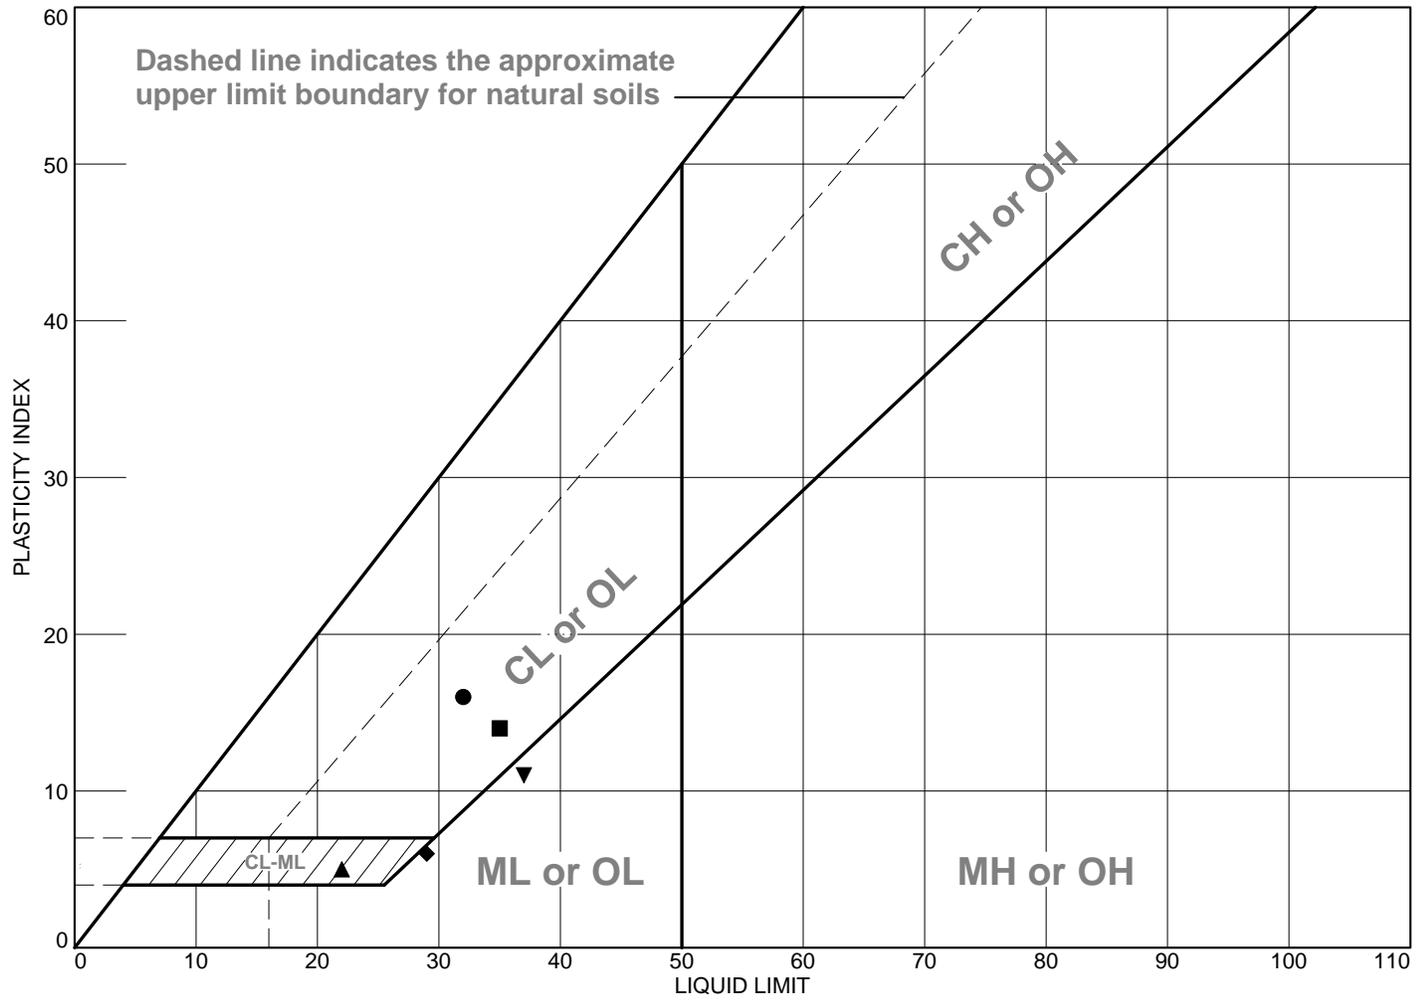
# LIQUID AND PLASTIC LIMITS TEST REPORT

Material Description	Sampled	Tested	Technician	LL	PL	PI	%<#40	USCS
●	Gravelly Lean Clay (CL)			SG	32	16	16	65.6	CL
■	Clayey Gravel (GC)			LS	35	21	14	20.3	GC
▲	Silty Clayey Sand with Gravel (SC-SM)			JC	22	17	5	68.9	SC-SM
◆	Sandy Silt with Gravel (ML)			JC	29	23	6	78.4	ML
▼	Gravelly Silt with Sand (ML)			JC	37	26	11	71.2	ML

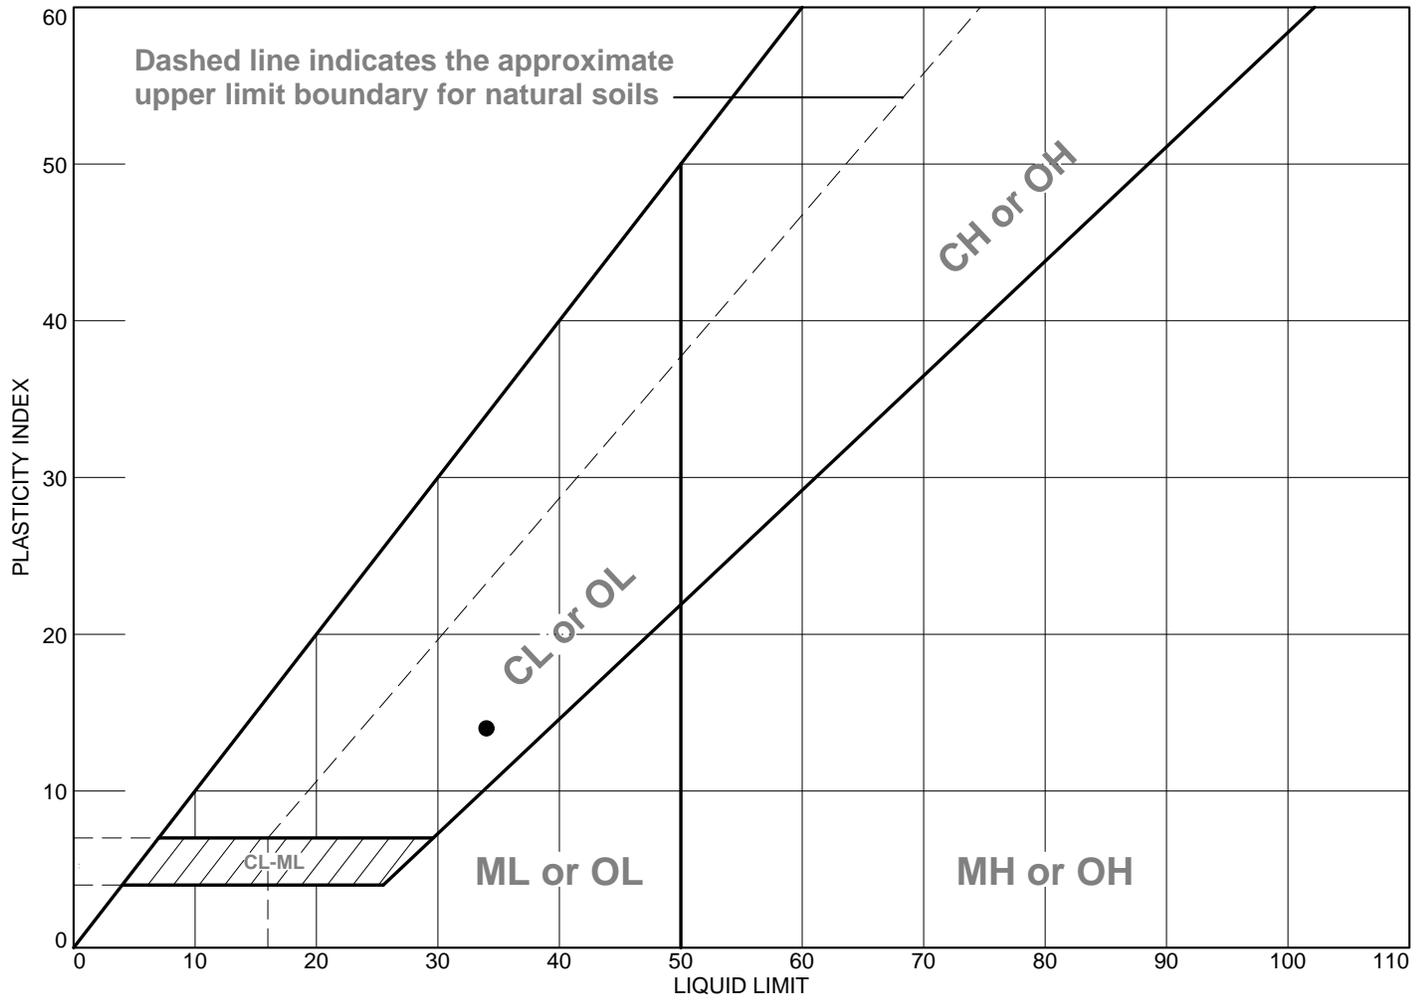
# LIQUID AND PLASTIC LIMITS TEST REPORT

Material Description	Sampled	Tested	Technician	LL	PL	PI	%<#40	USCS
● Lean Clay with Gravel (CL)			SG	34	20	14	78.6	CL

**Project No.** 2023004      **Client:** Commonwealth of Kentucky, DECA  
**Project:** Skyview Estates  
 **Location:** B-7 Bulk Sample      **Sample Number:** 24386

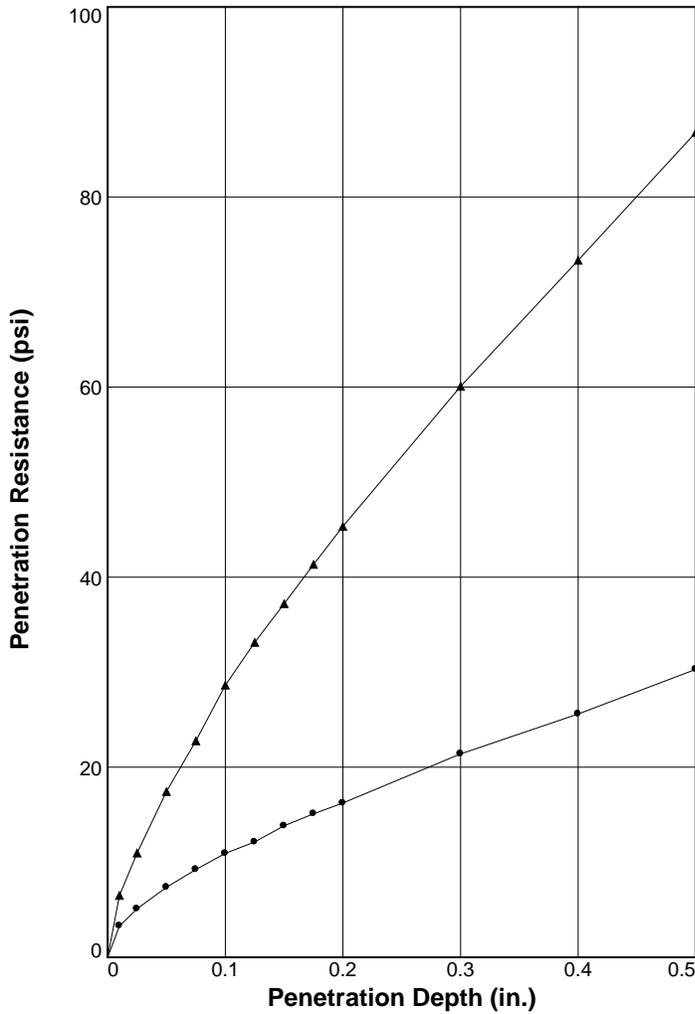
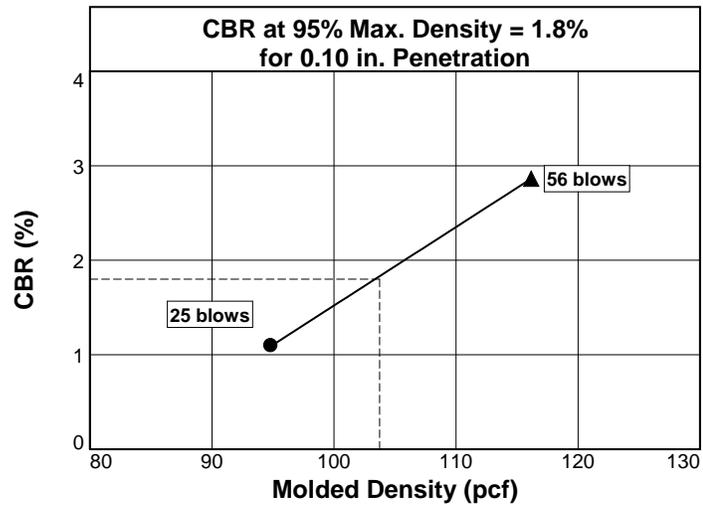
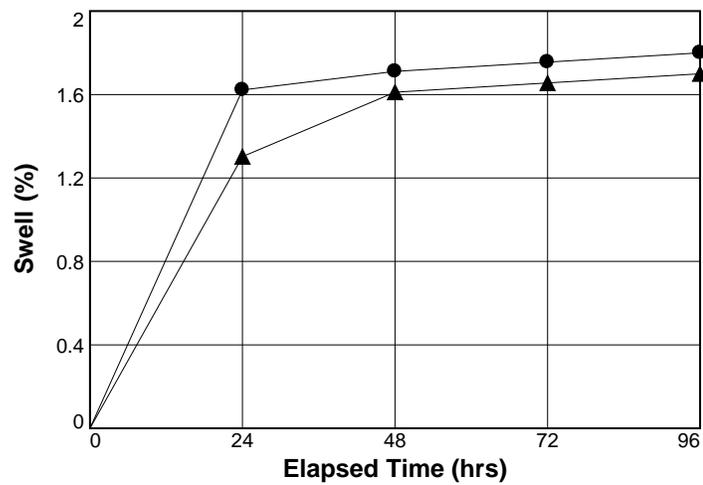
# BEARING RATIO TEST REPORT

Molded			Soaked			CBR (%)		Linearity Correction (in.)	Surcharge (lbs.)	Max. Swell (%)
	Density (pcf)	Percent of Max. Dens.	Moisture (%)	Density (pcf)	Percent of Max. Dens.	Moisture (%)	0.10 in.	0.20 in.			
1 ○	94.9	86.9	12.0	93.2	85.3	19.2	1.1	1.1	0.000	12.58	1.8
2 △	116.2	106.4	12.0	114.2	104.6	17.1	2.9	3.0	0.000	12.62	1.7
3 □

Material Description	USCS	Max. Dens. (pcf)	Optimum Moisture (%)	LL	PI
Lean Clay with Gravel (CL)	CL	109.2	12.4	34	14

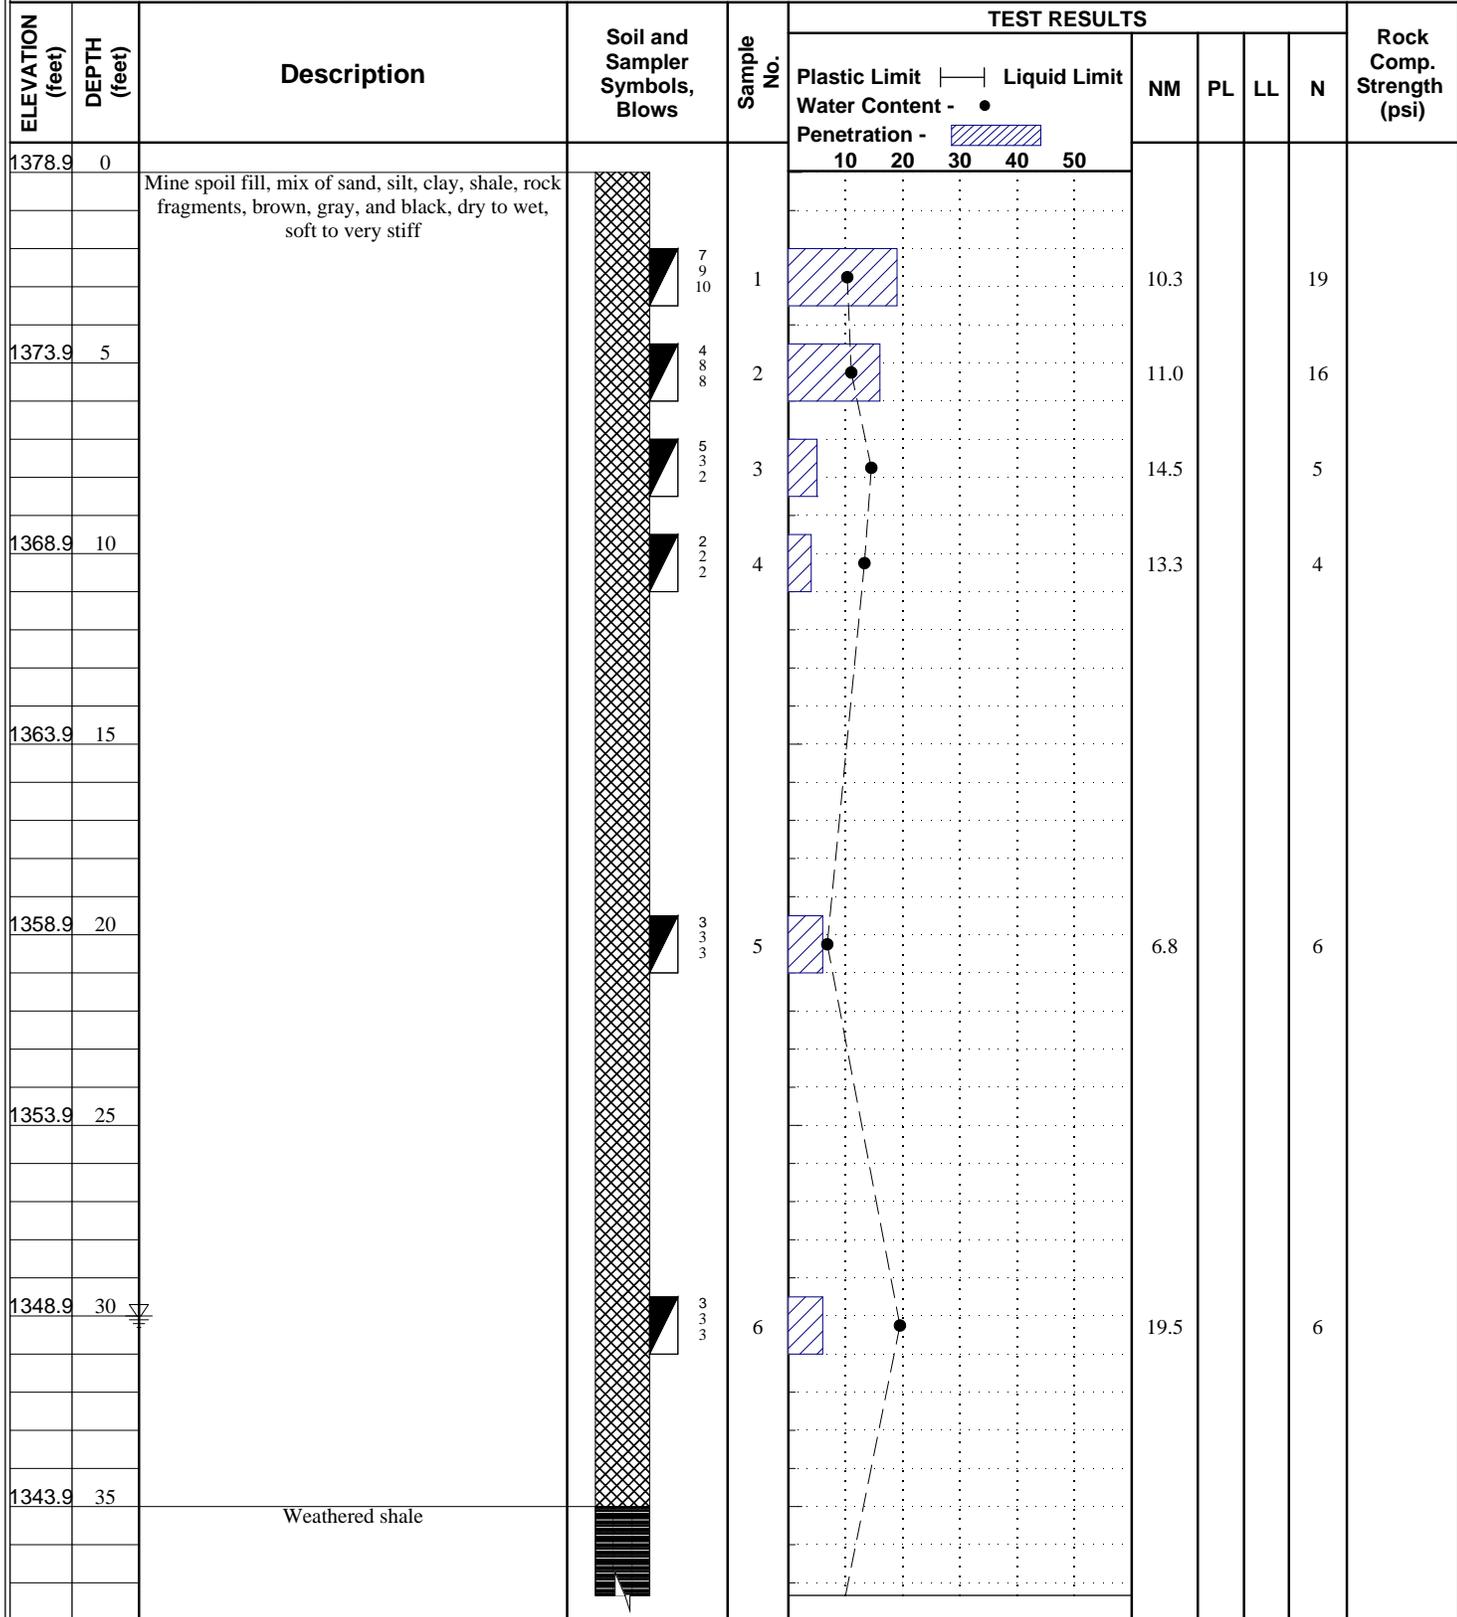
**BORING No. B-10**

Water at 30.0 ft. after SPT sampling, water at 23.0 ft. after coring

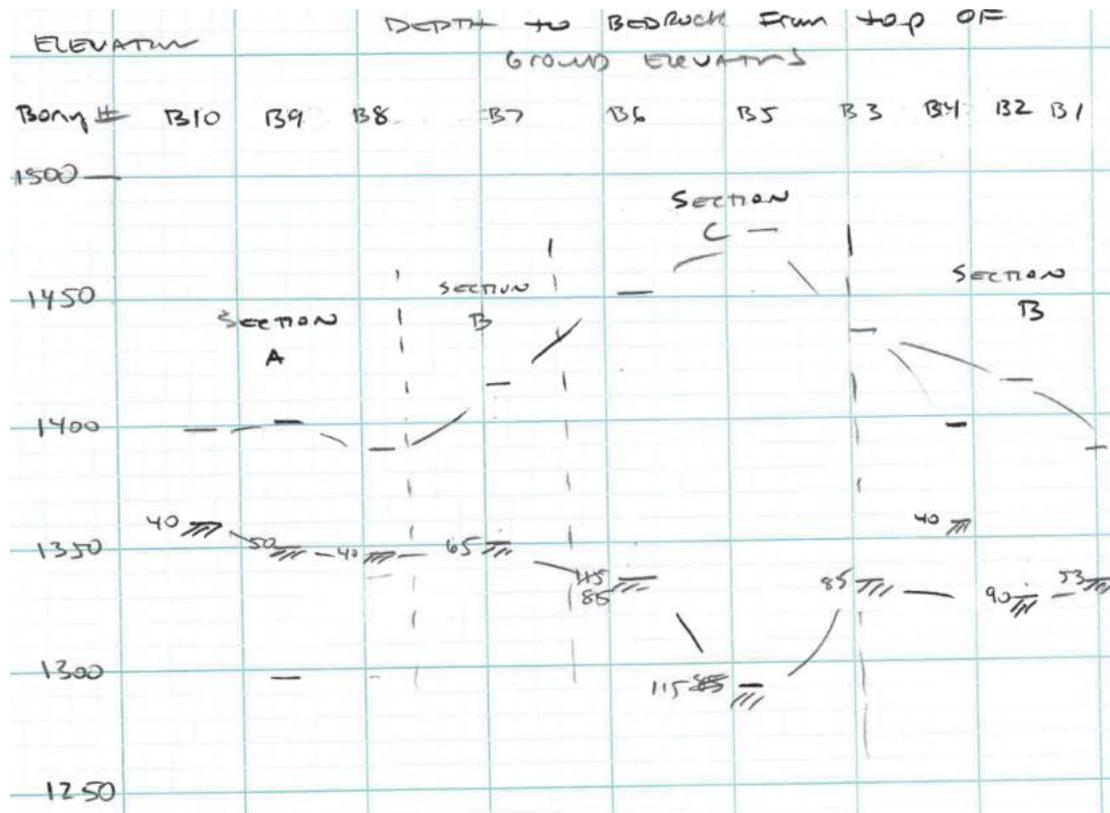
Figure 1: Rough profile sketch of mine spoil thicknesses

Upon review of the boring data, the site ranges in elevation from about 1400 feet msl to 1470 feet msl. The bedrock depths range from 40 feet to about 115 feet which corresponds to elevation of about 1560 ft msl to 1290 feet msl. A rough profile is shown in Figure 1.

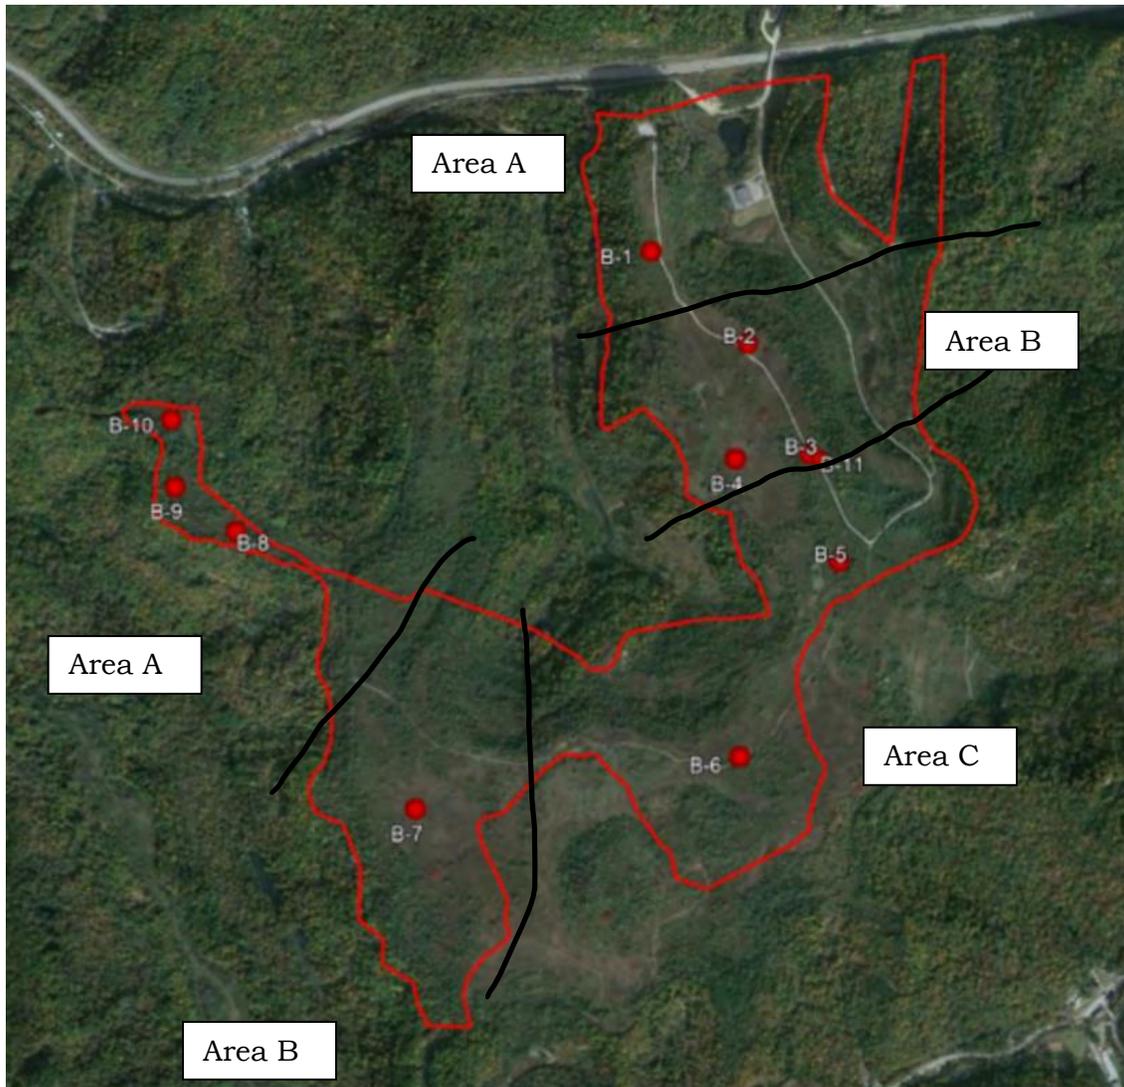
spoil fill depths less than about 50 feet, Area B is for portions of the site with mine spoil fill depths greater than 50 feet but less than about 75 feet and Areas C for portions of the site with mine spoil fill depths from 75 feet to about 115 feet. The drawing in Figure 2 shows the general areas identified from the boring data. From the limited boring data, there appears to be three distinct bedrock elevations. The bench in area A is about elevation 1350 ft, the bench in Area B about 1325 and in Area C, the mine spoil may have been placed in an old valley.

Figure 2: Aerial view and boring layout of site. The site is divided into areas based on the depth to bedrock from the boring data. It should be noted that no geophysical testing was conducted, therefore the depths to bedrock was only accurate at the specific boring location. The division lines are very approximate and interpreted from the adjacent boring.

To reduce the risk of differential settlement, the mine spoil fill thickness must be consistent beneath any individual building footprint. Also, the depth to bedrock must also be relatively consistent beneath any proposed building location. The building must not straddle areas of large variations in bedrock depths between benches or be located over a site with a partially buried mine bench. Individual buildings should be completely in one specific Area as shown on Figure 2.

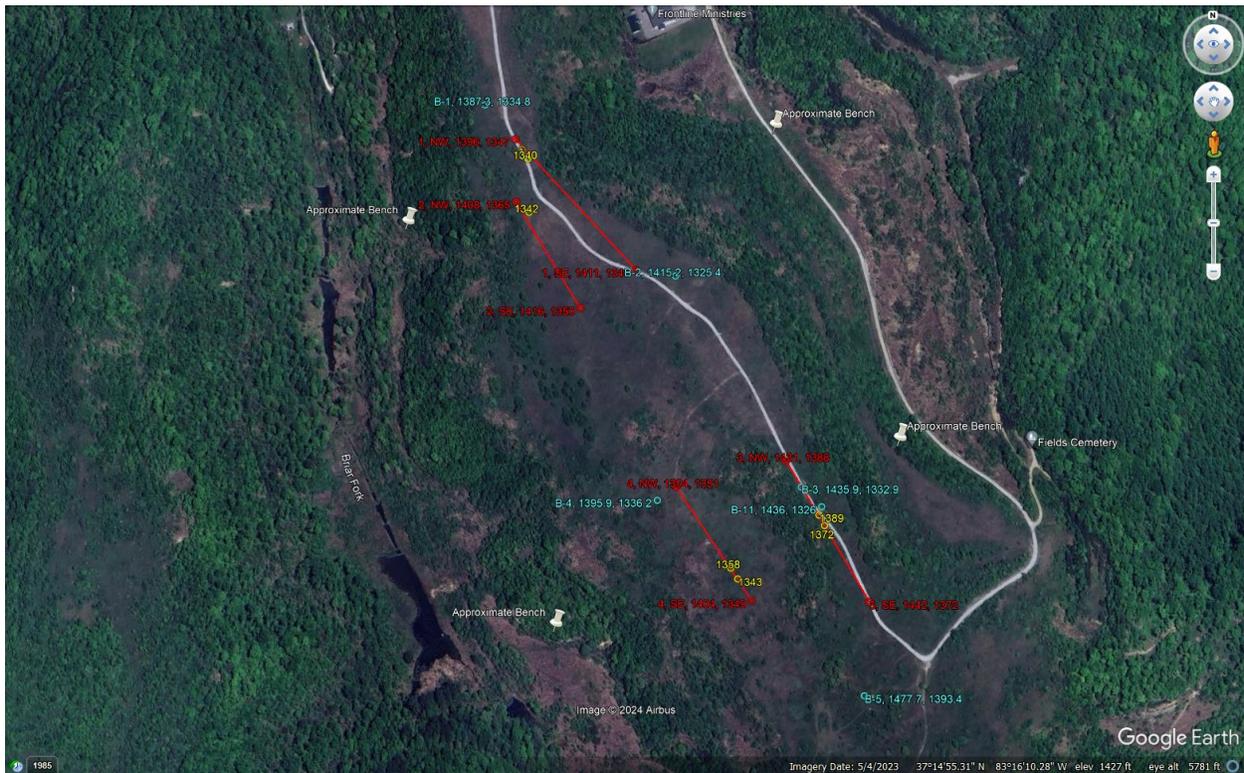
Figures 1 and 2 illustrate the approximate locations of the original geotechnical borings and the MASW lines conducted within the planned development. The LE Gregg boring locations are illustrated in blue with the top of ground elevations at the time of drilling and the listed refusal depth elevation. B-1 and B-11 were adjusted higher for weathered shale above refusal. The Multi-channel Analysis of Surface Waves (MASW)

lines are illustrated in red with the directional point, approximate top of ground elevations, and the approximate elevation that the shear wave velocity is greater than 2,500 feet/second indicative of bedrock. Within the MASW line is the approximate location of the benches observed in the geophysical data based on latitude and longitude. Note that the actual MASW Lines 1 and 3 along the existing gravel road were inline with the road rather than the depicted straight line. The white pins illustrate the approximate bench locations illustrated from our review of the geotechnical report based on the initial data.

Figure 1: Aerial photograph via Google Earth with the KMZ of the approximate boring locations provided by LE Gregg and the endpoint MASW lines provided by NSG.

As discussed the meeting, minor benches of approximately 10 to 20 feet in height were observed in Lines 1, 2, 3, and 4 running northwest to southeast. Based on the boring logs, the refusal/bench depths in B-1, B-2, and B-4 are relatively consistent with Lines 1, 2 and 4.
