Subject:       Compilation of Geotechnical Submittals  
                  **Skyview Estates**  
                  Hazard, Kentucky  
                  Project Number: 24020013SHE

**Geotechnical Engineering  
Exploration**

**Sky View Estates  
Perry County, Kentucky**

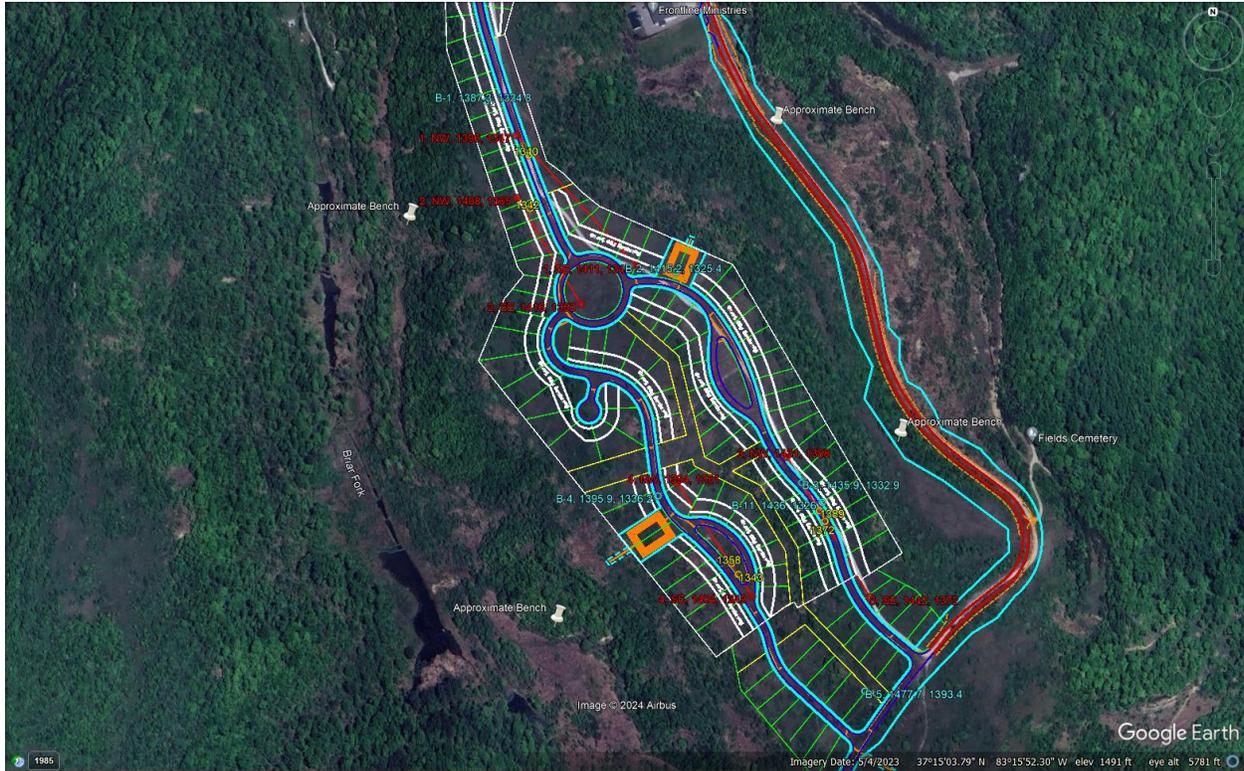
Figure 2: Aerial photograph via Google Earth with the KMZ of the approximate boring locations provided by LE Gregg, the endpoint MASW lines provided by NSG, and the planned development provided by HMB.

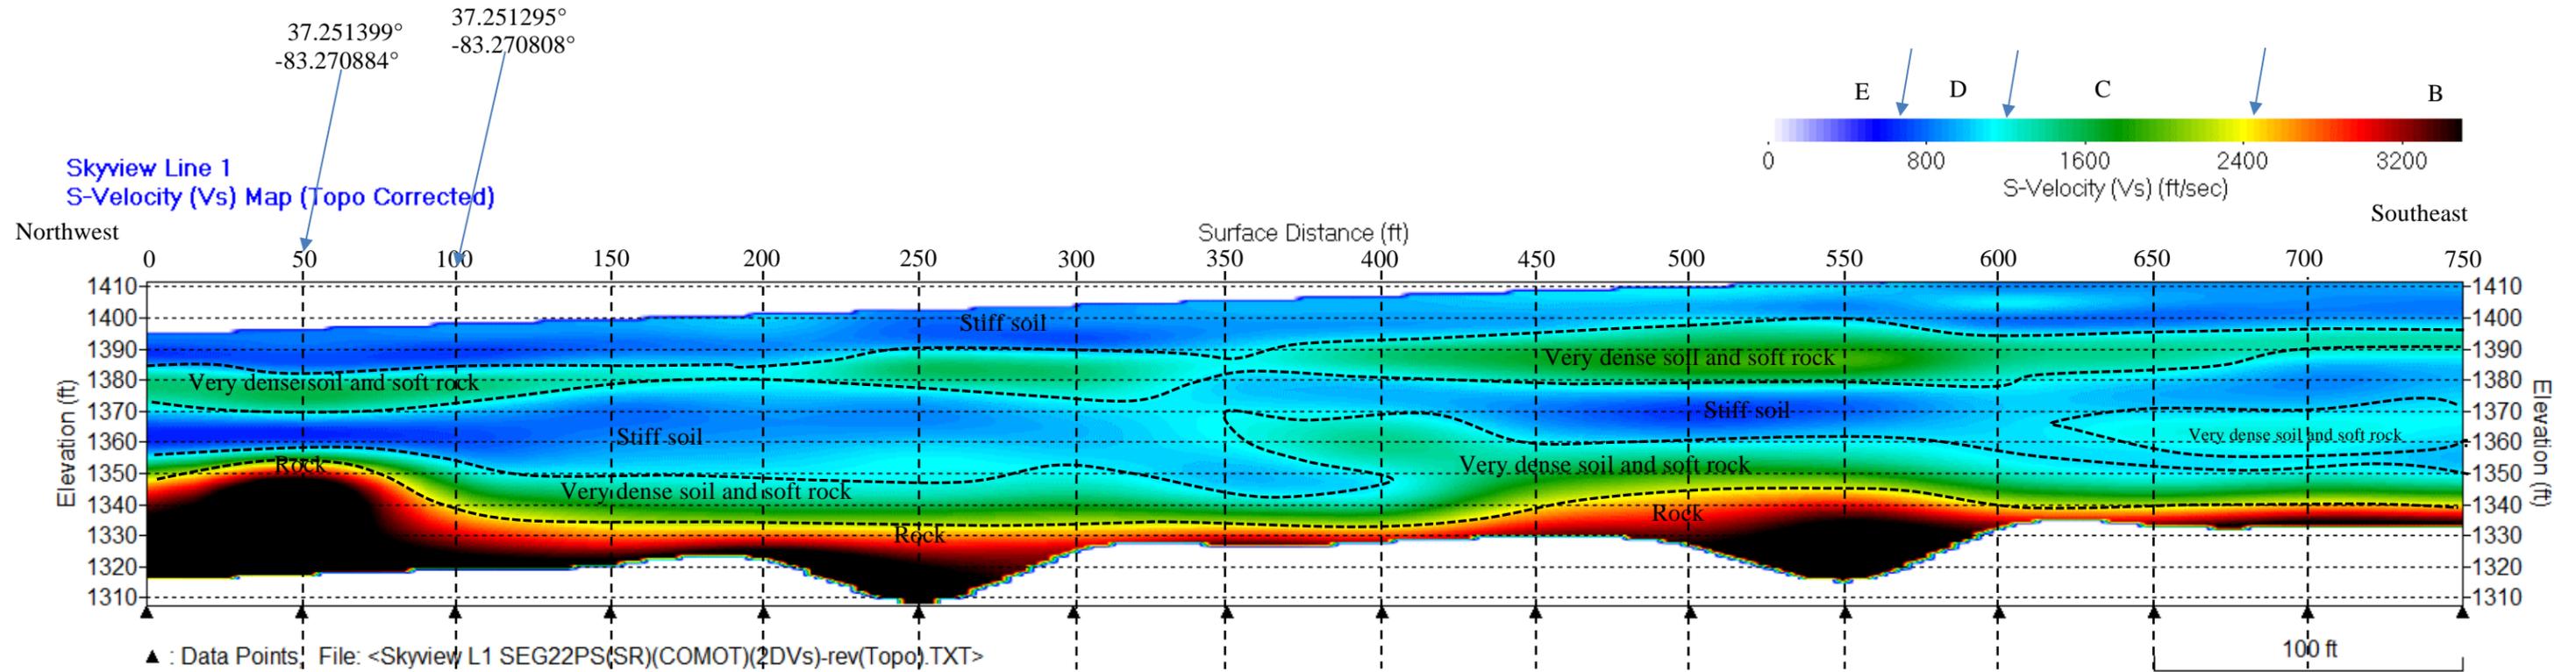
Figure 5, MASW Profile Line 1  
Drawn By: Thomas Brackman

Study of the MASW profiles (Figures 5 through 8) suggests the locations of the mining benches can be seen as a drop in the Class B, Rock layer (yellow to red colors) or bedrock surface. MASW Line 1, Figure 5, data appears to show a decrease in elevation between Stations 50 and 100 feet. Note that the transition may occur between these points as the model interpolates between the two locations. MASW Line 2, Figure 6, data suggests a similar transition between Stations 0 and 50 feet. MASW Line 3, Figure 7, data reveals a possible transition between Stations 250 and 300 feet. MASW Line 4, Figure 8, a transition between Station 350 and 400 feet can be observed. Coordinates for the beginning and end of the inferred transition zones can be seen on each Figure indicating the approximate location of the past mining benches.

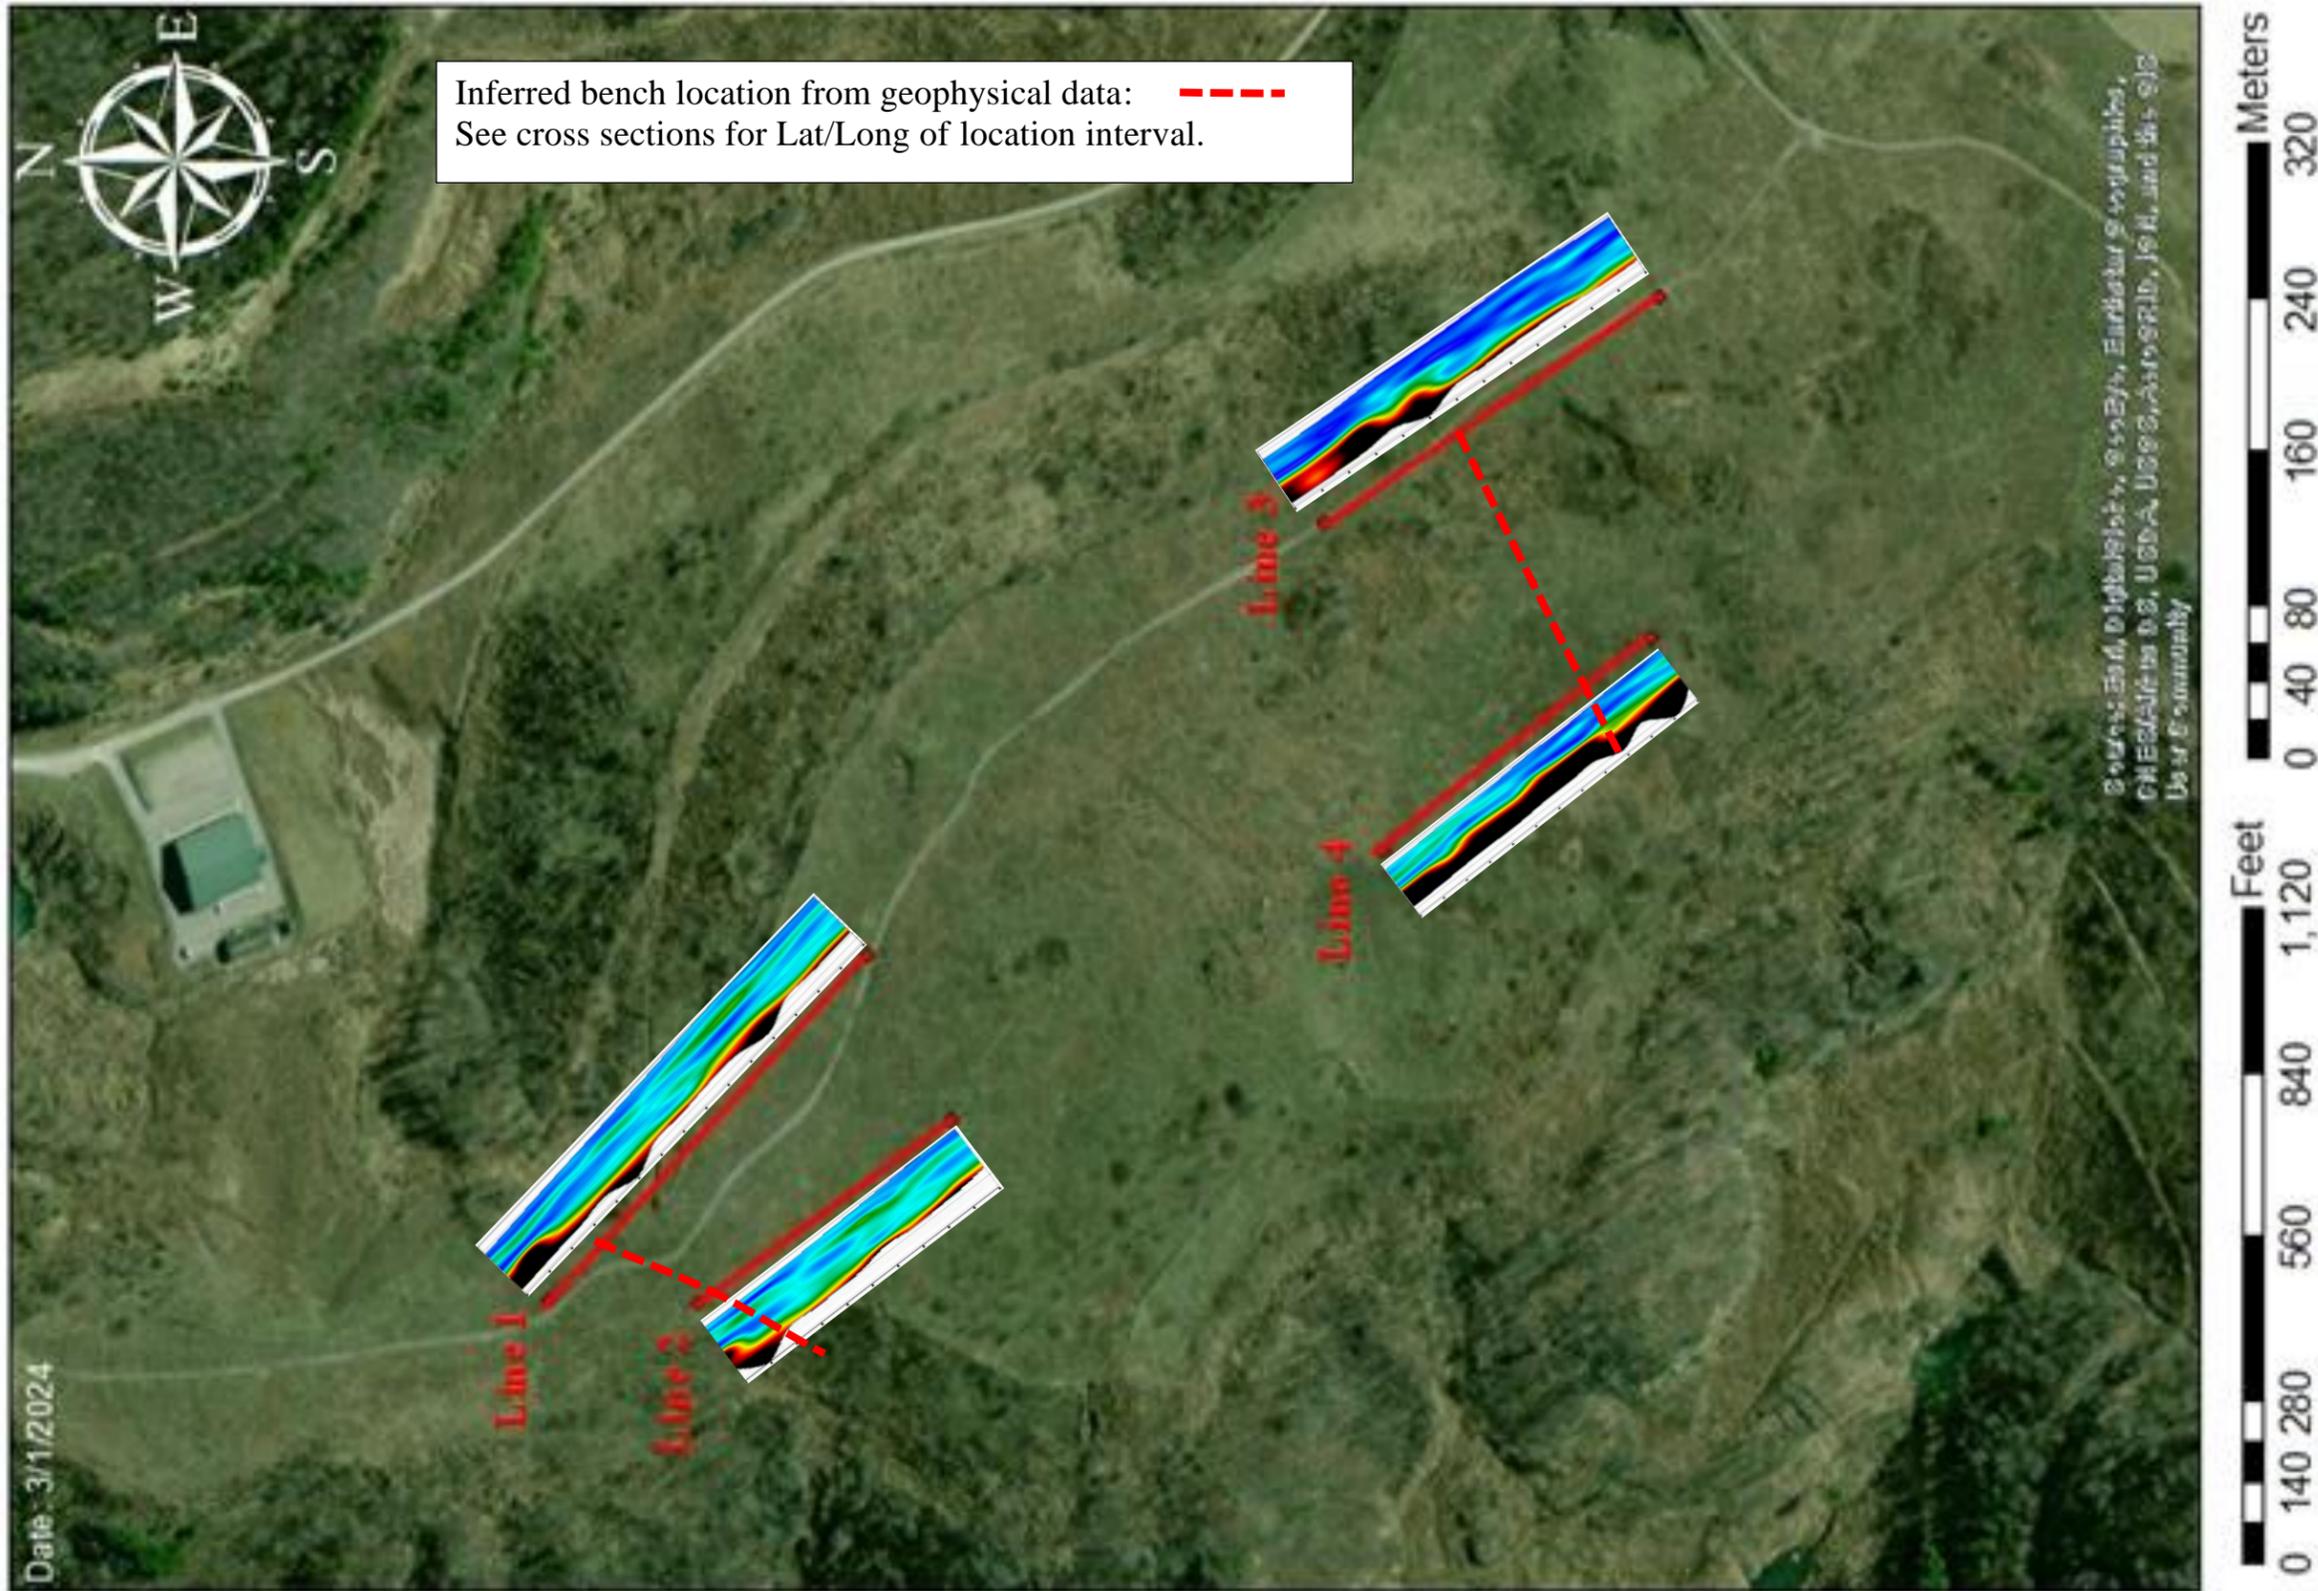
Figure 9, MASW Overlay  
Drawn By: Thomas Brackman

Figure 9 is an overlay of all the MASW lines conducted across the site. A red line was drawn to show the inferred location of the benches. Refer to Figures 5 – 8 for more accurate locations via coordinates.
